INSIGHT™

ISSUE NO. 13

A technical newsletter by Raths, Raths & Johnson, Inc. for the construction industry.

Grouted Stone Facade Kerf Failures

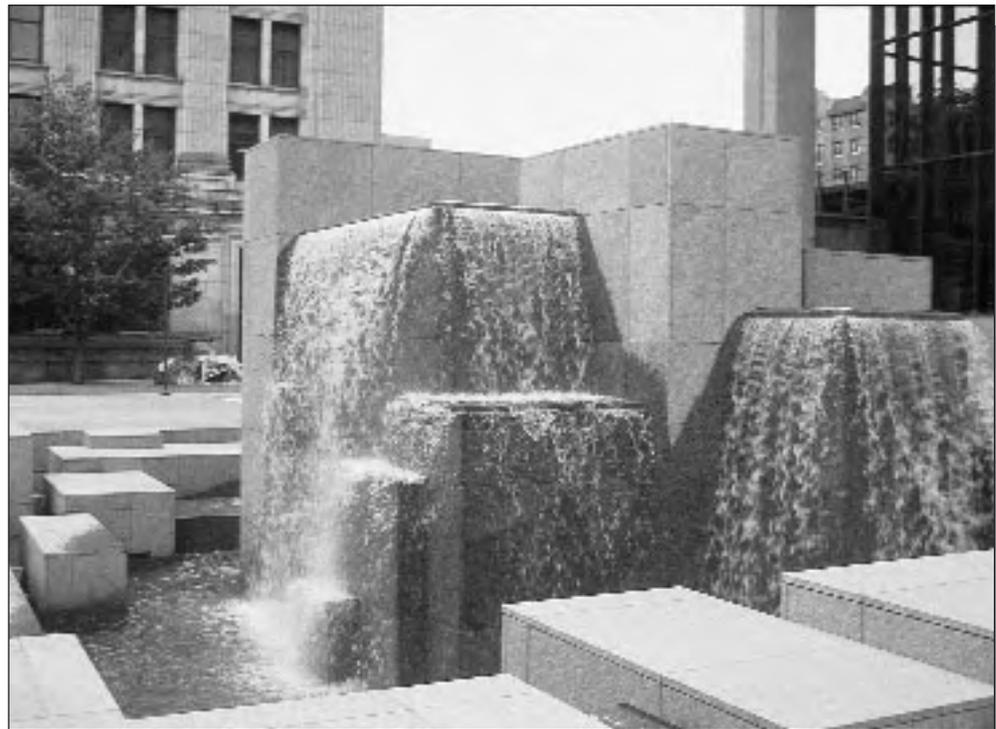
Stone structures can develop connection problems if expansive grout is used in the kerfs.

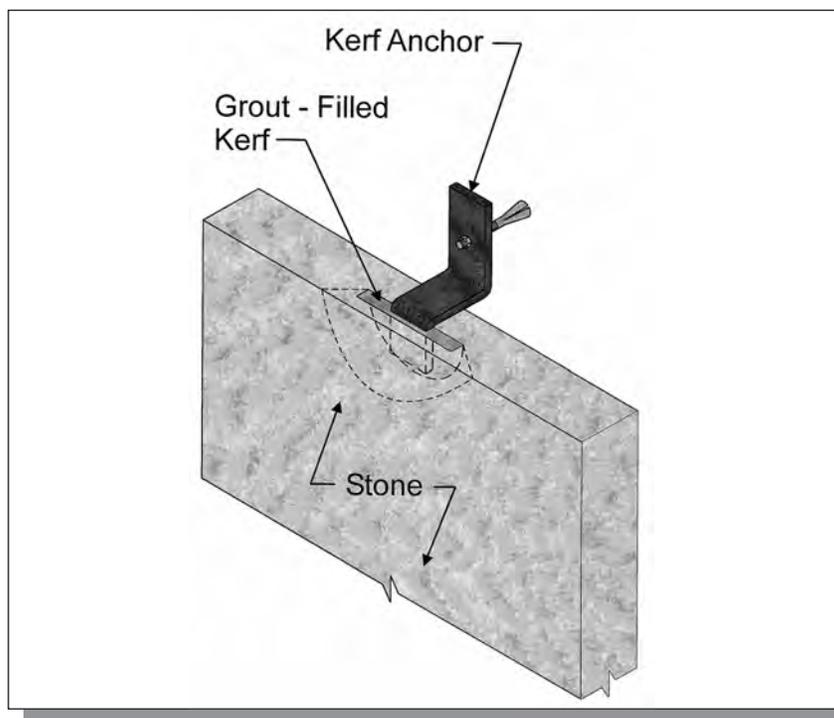
Figure 1 - Plunge cut kerf anchor.

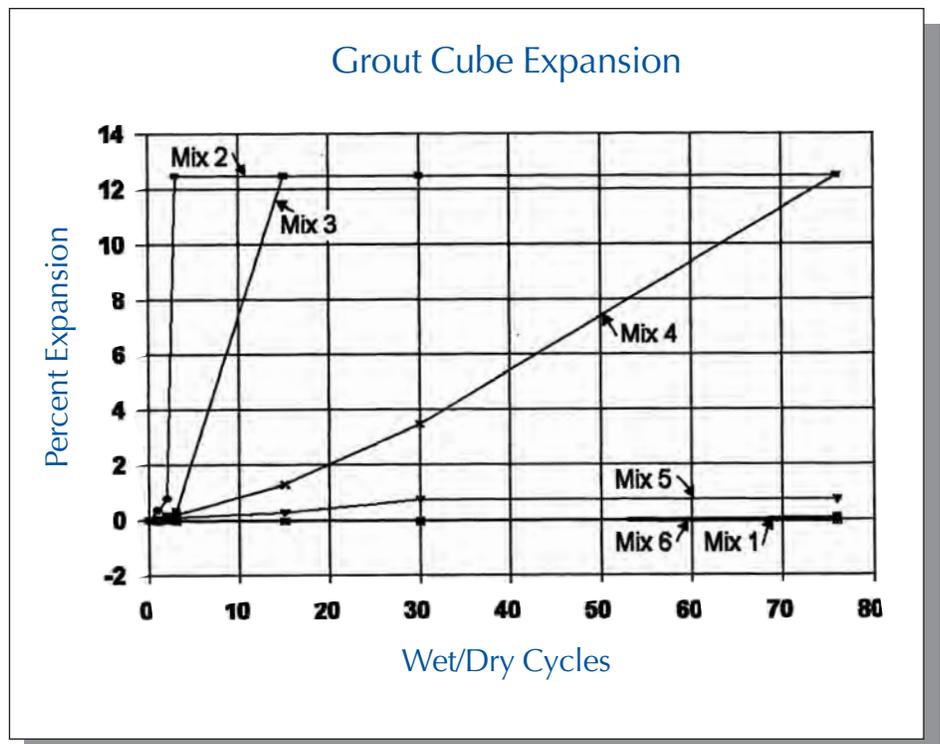
Figure 3 - Grout cube test plot of percent expansion versus wet/dry cycles.

expansion by visual examination for cracking and periodic measurement of the cube specimen dimensions. The kerf specimens were periodically examined for cracking of the stone. The results were astounding. As shown in Figure 3, Mix 1 (no gypsum) experienced no expansion or cracking. Mixes 2, 3, and 4 all rapidly disintegrated due to expansive fracture. Mix 5 initially cracked and expanded, but then stabilized. Mix 6 experienced minor initial cracking, and then shrank in size as surface material dissolved during repeated wetting. Of the stone kerf specimens, stone fracture was observed on all Mix 2 samples, regardless of stone type, after only 15 wet/dry cycles (Figure 6). After 80 cycles no other kerf failures were observed.

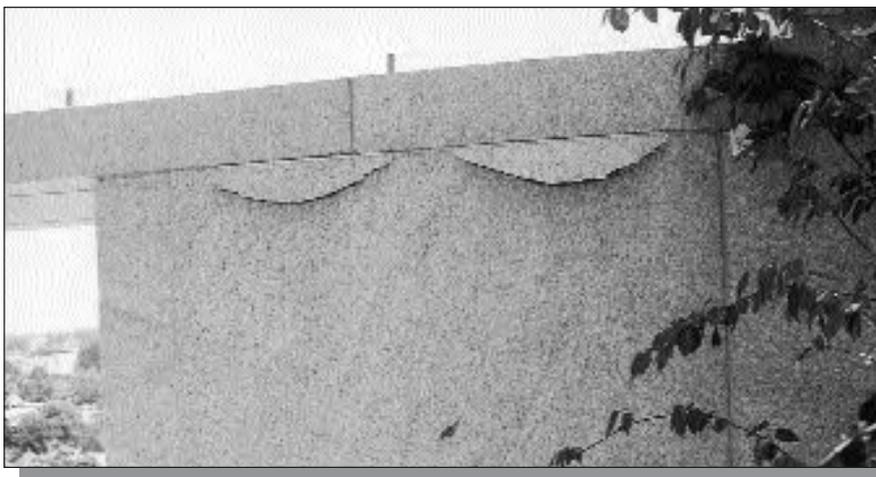
resulting in large volumetric expansions of the original grout placement that can split concrete and fail stone cladding kerf connections (refer to Figures 2, 3 and 5 of this issue for more information).

Figure 2 - Expansive grout causes surrounding stone to crack thereby weakening the connection resulting in an unsafe condition.

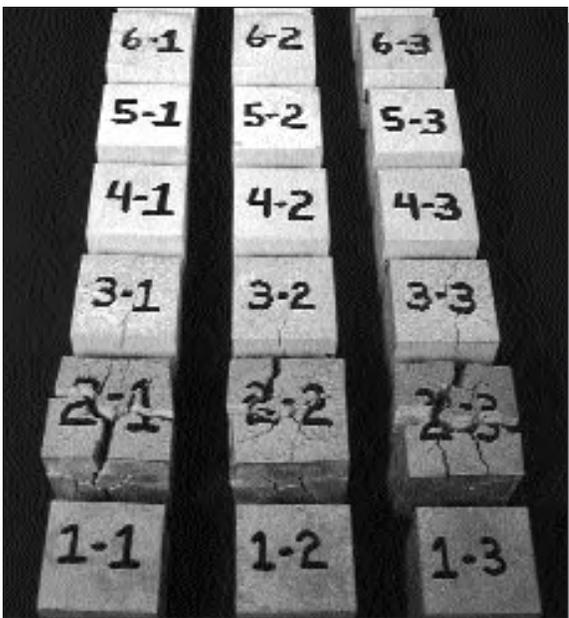
Figure 4 - Test grout cube samples after 80 wet/dry cycles.

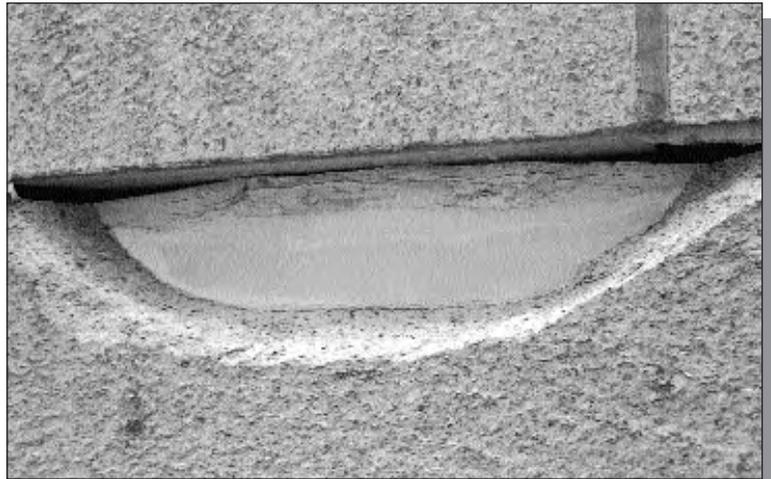
Close examination of some of the failed stones revealed expansive patterns within the kerf grout (Figure 5). **Laboratory petrography analysis of the grout identified clusters of ettringite within a matrix of portland cement, gypsum, and silica sand.** Ettringite is formed by an expansive chemical reaction between portland cement and

gypsum under moist conditions (refer to this month's Tech Tip article). The expansive conversion of portland cement and gypsum had forced the failed kerfs apart, much like air inflating a tire, eventually causing the stone to fracture. Mystery solved! **Grout expansion from weather-related wet/dry cycling of the stone (and the grout within the kerfs) had caused the kerf failures.**

Figure 5 - Close up of kerf grout pocket. Expansion of grout into joint and outward caused stone to fail.

In order to avoid grout-related failures, including the connection failures that befell the granite facade discussed in this month's *Project Profile* article, **RRJ recommends adhering to the following simple rules when specifying grout for exterior applications:**

- Never use gypsum-based grouts in exterior applications or interior applications subject to wetting, because softening, wash-out, metal corrosion, and concrete attack may occur.
- Avoid preparing your own "custom" grout. Instead, stick with a proven commercially available product.
- If you must prepare your own grout, never add gypsum to a portland cement base. Ettringite expansion can fracture concrete, granite, and other building stones.
- When using commercially available grout products avoid mixing different products, even from the same manufacturer. The hybrid formed may have poorer performance than either of the parent materials and could result in expansive cracking from the formation of ettringite.

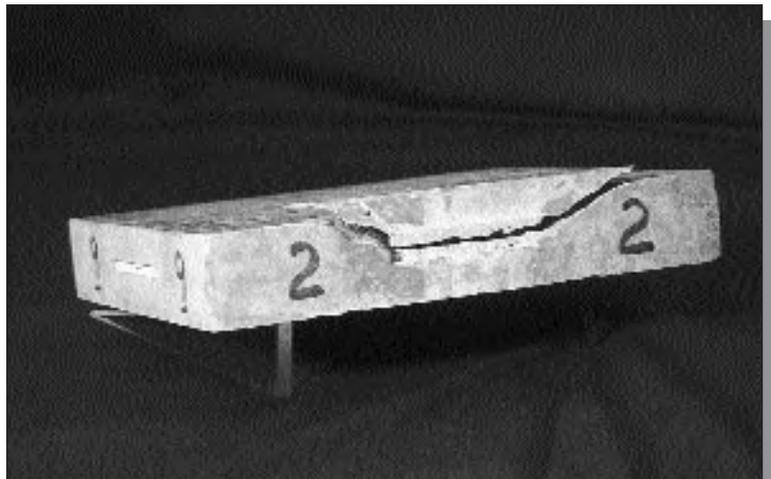
Figure 6 - Stone specimen with expansive grout in the kerf simulates field performance in the laboratory.
