INSIGHT™

ISSUE NO. 12

Using Precast to Restore a Vintage Limestone Facility

Rust Pack Causes Building Damage

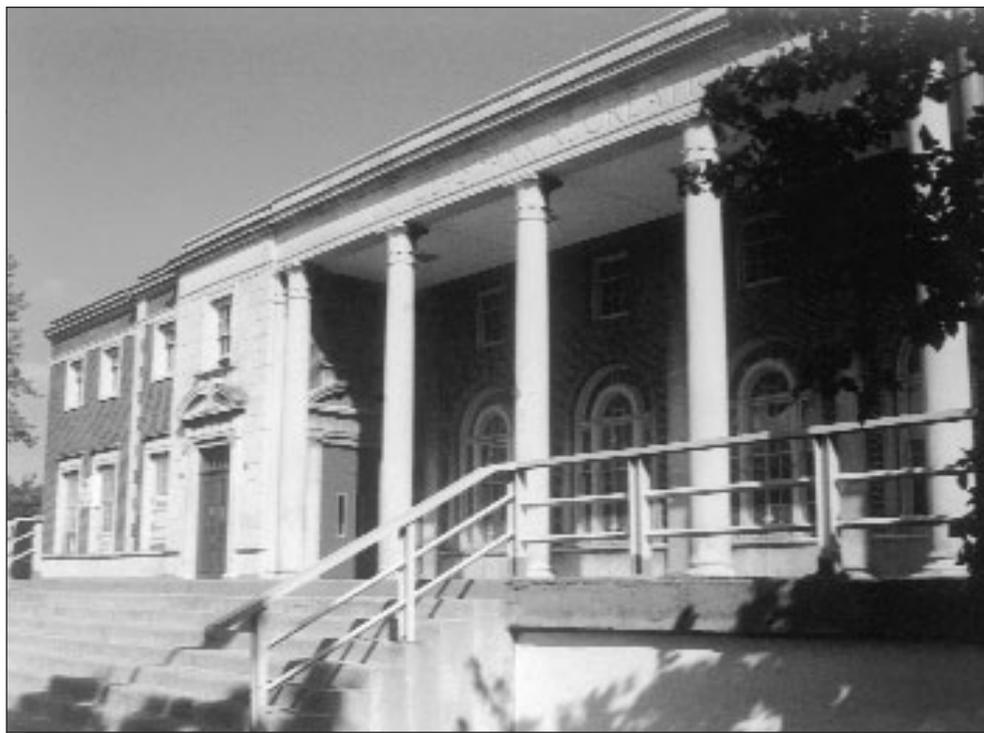
Douglas Park Field House in Chicago, Illinois after the cornice restoration was completed.

RRJ's repair design consisted of shoring the existing roof slab that was supported by the cornice construction, and removing the existing limestone, brick and steel beam. Limestone pieces were photographed and catalogued before removal to facilitate reinstallation in their original locations. The deteriorated steel beam was replaced with a new architectural

precast concrete beam spanning between the existing masonry columns. The soffit of the precast beam was cast with the same shape, color, and texture as the original damaged limestone soffit. A waterproofed drainage cavity was incorporated into the design to collect and expel any water that infiltrated through the limestone joints. The original limestone cornice pieces were cleaned and reattached with new stainless steel anchors, completing the restoration. **The repair saved the Park District costs associated with replacing damaged limestone soffit pieces, retained the original ornate stone carvings, and greatly improved the long-term resistance to future water infiltration.**

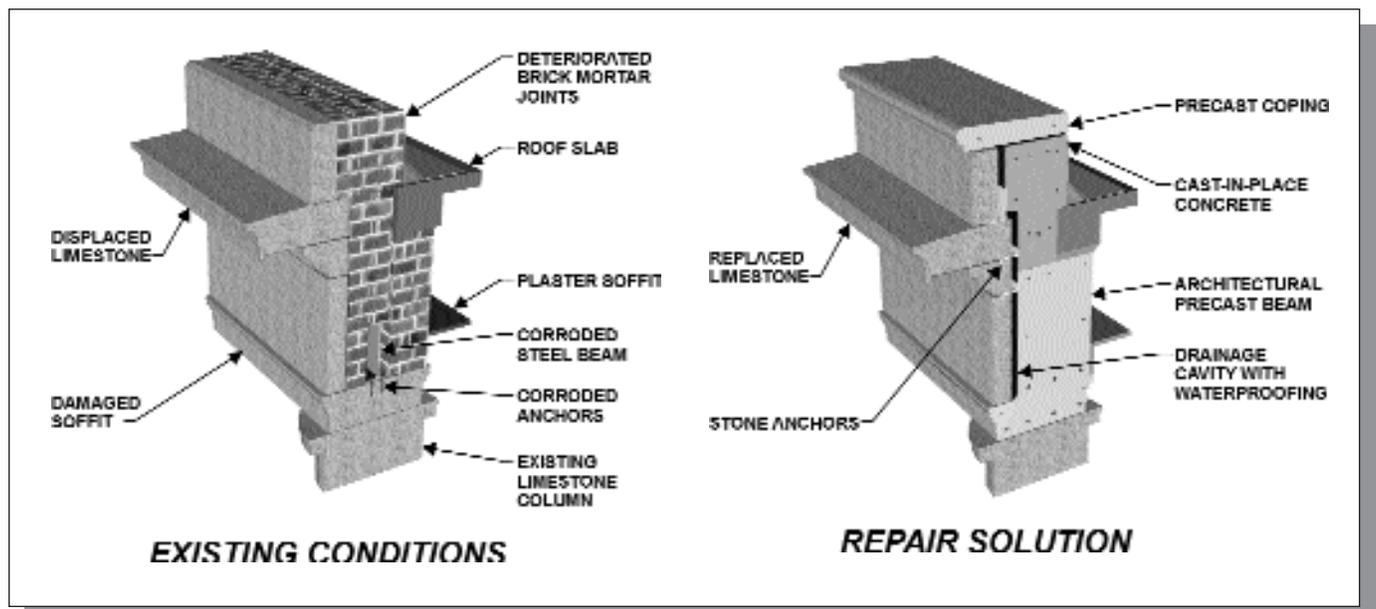
deterioration of brick mortar joints and embedded anchors that secured the limestone to the brick. A steel beam supporting both the limestone and brick masonry was also observed to exhibit corrosion. The limestone and brick masonry had displaced significantly as a consequence of the deterioration. The magnitude of displacement dictated a repair which would require complete removal and reconstruction of the limestone cornice and supporting structure.

Figure 1 — One-piece precast soffit/beam replaces limestone soffit and corroded steel beam.

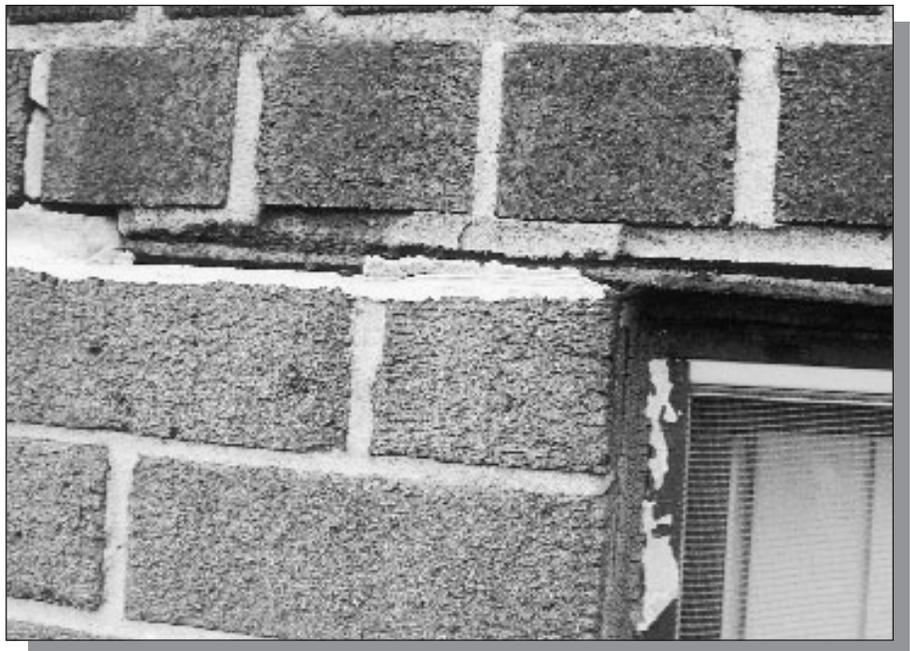
Several large pieces of limestone at the Douglas Park Field House were pushed apart by expansion or packing of rust flakes caused by corrosion of the supporting metal anchors and steel beams. These displacements caused cracking, and in-turn, allowed more water access to the embedded metal components which led to additional corrosion and rust flaking. **Damage due to rust packing is a significant consideration in older structures utilizing unprotected steel supporting members.** This article highlights the mechanism and symptoms of rust pack damage.

Rust packing is the term used to describe the build-up of flakes of oxide or rust which results from the corrosion of steel. It occurs in all ferris types of structural components including steel plates and beams of bridges, embedded steel supports of masonry buildings, and steel reinforcing of concrete structures. Corrosion, which can result in significant damage and restoration costs, occurs when the unprotected metal is exposed to moisture and oxygen. **The mechanism for damage to surrounding materials occurs when the rust flakes build-up, increasing the volume of the steel member, creating forces against the surrounding building materials, and therefore causing movement and/or cracking.** The volume of oxide or rust produced by corrosion is about eight times that of the parent metal — full corrosion of $\frac{1}{8}$ inch of metal will cause about 1 inch of rust pack.

Figure 2 — Rust packing of lintel caused cracking of brick wall.
