INSIGHT™

ISSUE NO. 14

Case Study of
Wall Condensation
Problems – Computer
Center, Diagnosing
the Problem

Case Study of Humidified Computer Center – Diagnosing the Problem

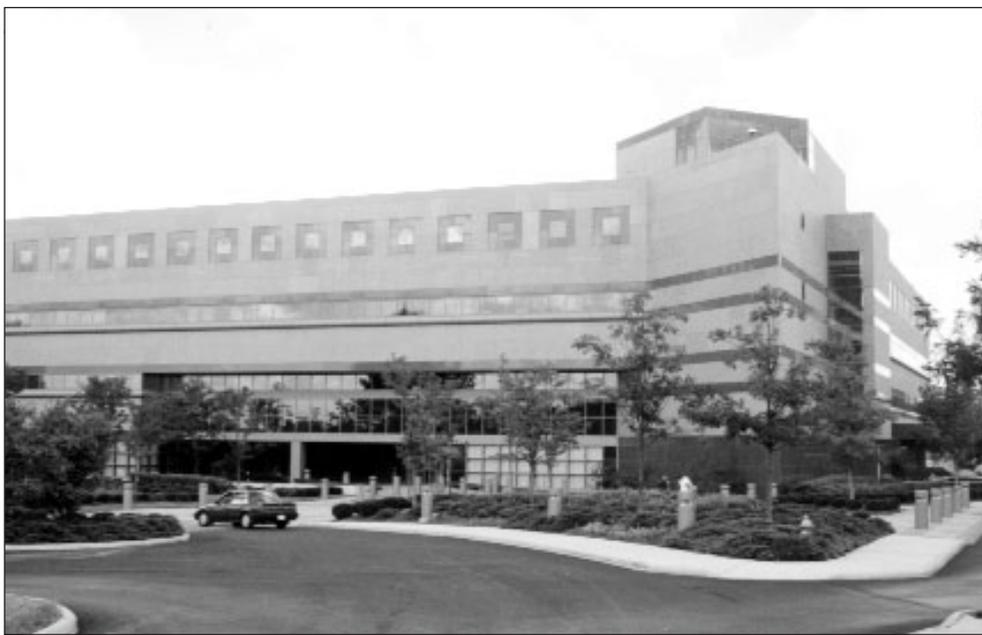
Computer center with exterior envelope condensation problems.

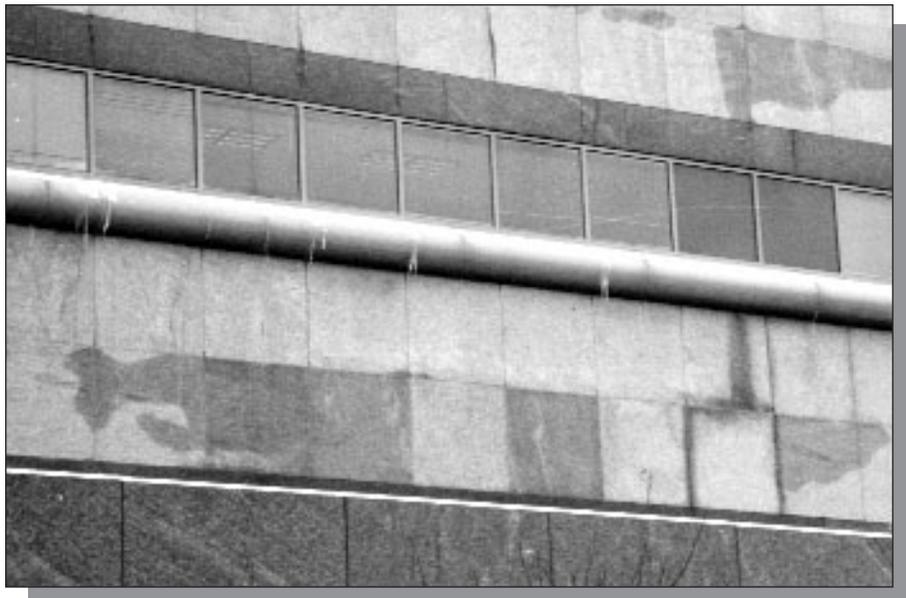
A humidified computer center in the upper Midwest exhibited symptoms of condensation problems including wall weeping and water discharge in cold weather, at times when there was no precipitation to account for the water. In addition, water and frost built up on the inside surfaces of window framing and glass, even though the windows were glazed with insulated glass units. The original wall design incorporated three distinct vapor retarders: foil-backed drywall, plastic sheeting and foil-faced insulation batts. Clearly, diffusion was considered in the original design, and a steady-state analysis indicated that at least two of the three vapor retarders were needed to control diffusion. Unfortunately, the way the wall was designed and assembled permitted interior humidified air to flow around the interior wall finishes and the vapor retarders, and to reach the cold back side of the exterior granite cladding. An initial assessment of the problem indicated that control of air flow into the wall was inadequate, and an air barrier was needed.

The instrumentation program verified that movement of interior humidified air into the wall was the cause of the condensation problem. The program also indicated that the first repair alternative involving complete reconstruction of the wall from the interior side provided better condensation control than the second repair alternative involving upgrading the air barrier. The monitoring program made it possible to determine that the differences in behavior between complete reconstruction and simply upgrading the air barrier were small and would occur only under the most severe climatic conditions. It was also determined that the differences in behavior were temporary, and would not damage the wall.

Figure 1 – Weeping and icicles on the exterior due to condensation.

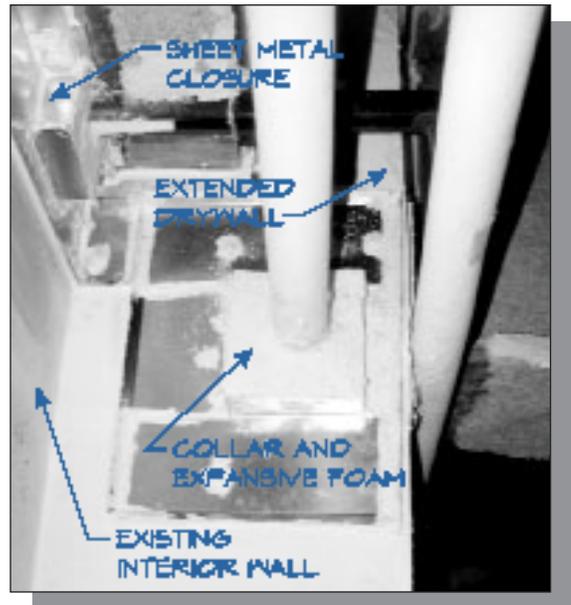
Figure 2 — Use of sheet metal collars and strip, sealants, and spray foam to upgrade the air barrier.

Most of the existing drywall and the existing triple vapor retarder were incorporated into a full air barrier. Strips of drywall around window penetrations were removed so that the existing vapor retarders could be tied together and sealed to the window frames. At the top and bottom of the wall, sheet metal closure strips were used to close gaps. A lip on the closure strips accepted sealant to complete the barrier. The drywall enclosure around exterior columns terminated at the level of the drop ceiling, creating exceptionally large air paths into the wall. The metal framing of the enclosures was extended to the underside of the slab above and additional drywall installed before the sheet metal closure detail could be applied. Penetrations through the drywall for exterior panel anchors,

pipe penetrations and diagonal braces posed a special problem. A sheet metal collar was developed for installation around the penetration, and the space within the collar was filled with expanding foam. The foam was then trimmed and sealed. The parapets were opened from the roof side and sealed with expanding spray foam and an elastomeric. Mini-vents were installed in the exterior sealant joints to ventilate the space behind the granite panels.
