# INSIGHT

ISSUE NO. 18

## Hampden Green Condominium Façade Replacement

## More Bad News About Gypsum-Based Grouts

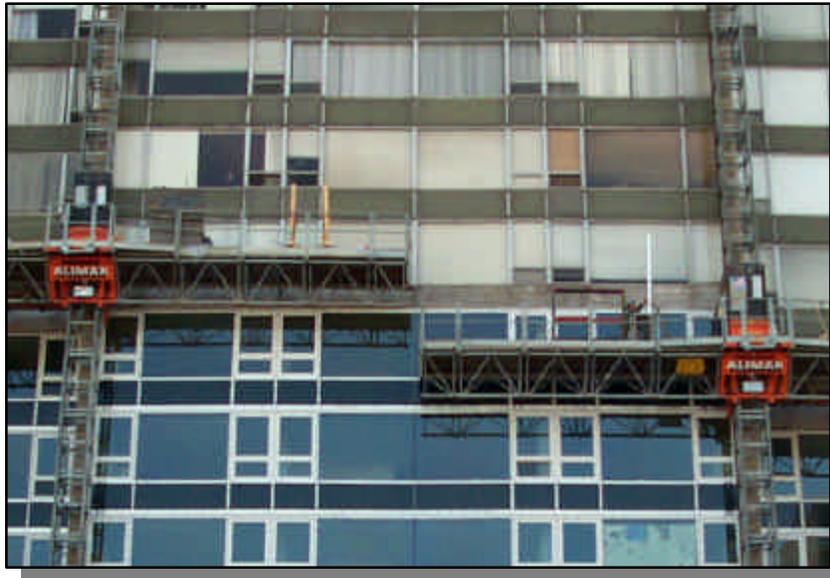
**RRJ’s investigation revealed the window system exhibited multiple deficiencies** including: leakage through glazing seals, open frame joints, worn and missing weatherstripping, and deteriorated sealants with multiple applications of sealants over the original materials. In addition, the porcelain-coated spandrel panel system installation resulted in

*Figure 2— Construction phase showing new curtain wall system on bottom and original windows and spandrel panels on top.*

poorly configured sealant joints and localized failures in the porcelain coating resulting in deterioration of the panel. RRJ also identified concerns related to the ability of the spandrel system to remain anchored during building code prescribed lateral wind loads. Due to the age and condition of the existing window and spandrel panel systems, retrofit of the existing units was ruled out.

**RRJ prepared design documents for complete replacement of the strip windows and spandrel panels.** A curtain wall system anchored to the concrete slab edge was selected as an alternate for replacement of both the windows and the metal spandrel panels due to strength deficiencies of the masonry knee walls resulting in the inability to meet current building code wind load requirements. The new curtain wall incorporated additional operable units in order to meet the current City of Chicago building code ventilation requirements.

To achieve this requirement, a flashing system located at the slab edge was incorporated in the design which not only provided temporary closure at the end of each day, but provided a back-up flashing system in the event of water infiltration through the perimeter systems at a later date.

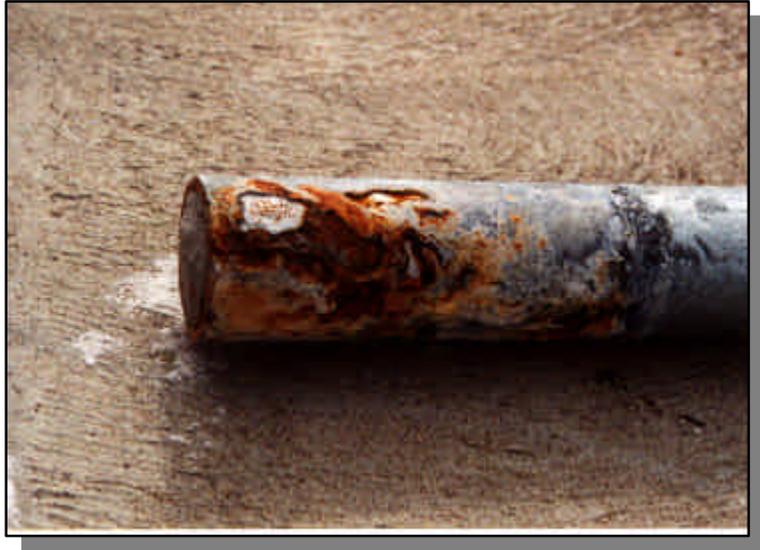
into concrete spall failures at hand and guard rail posts installed with gypsum-based grouts placed within sleeved and cored holes in concrete structural members have **identified accelerated corrosion of both painted and hot-dipped galvanized mild steel components.** In these cases, the post portions embedded in the gypsum-based grouts exhibited deterioration of the paint, consumption of the galvanizing,

severe corrosion of the steel, and cracking and spalling of the adjacent concrete construction (refer to Figures 3 and 4). The portions of the posts not in contact with the grout, and fully exposed to the weather, showed no paint failures, reduction in galvanizing thickness, or corrosion.

The stark contrast in performance between post portions within the grout and those areas left exposed to the weather clearly **demonstrates the aggressive corrosive environment created by wet gypsum-based grout.** These findings further validate *RRJ Insight* Issue 13 which recommended avoiding the use of gypsum-based grouts in exterior and other moisture prone applications, even in conjunction with the traditional corrosion protection mechanisms of painting and galvanizing.

Figure 4—Galvanized post showing deterioration of the portion within the gypsum-based grout.

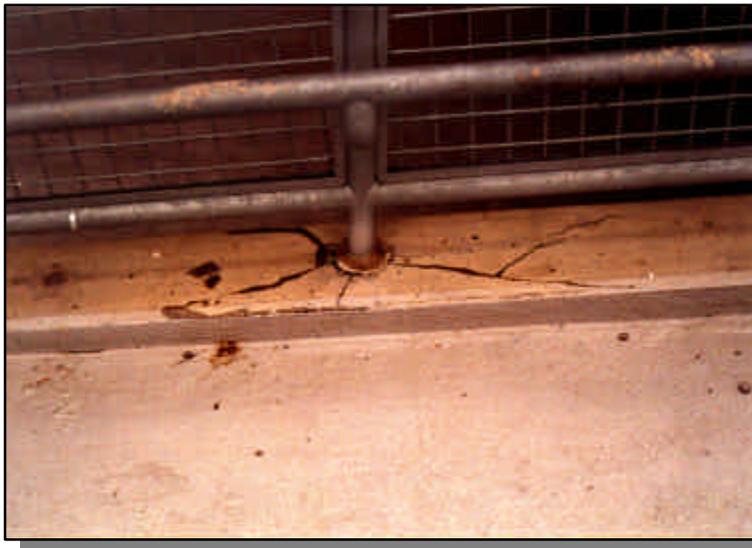
Figure 3—Concrete cracking at a combination hand and guard rail post installed with gypsum-based grout.
