INSIGHT™

ISSUE NO. 22

Structural
Restoration of a
Historic Chicago
Landmark

Building
Settlement
Repair
Considerations

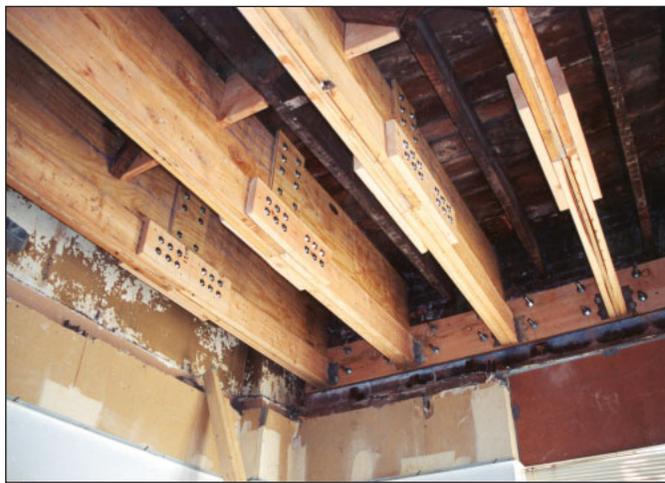
Figure 2 – Timber floor joist repair.

problem because the interior finish damage that would normally be expected to accompany this type of building movement was not present due to previous repairs by past owners/tenants. RRJ also found that sagging timber floor joists were split and cracked at certain locations due, in part, to the heavy concrete topping slab that was placed by past owners over the original hardwood floors.

excessive floor loads. In designing the repairs, RRJ took advantage of a high ceiling plenum space between a newer acoustic tile ceiling and the original plaster ceiling soffit fastened to the underside of the timber joists. Sagging floor areas were strengthened by supplementing existing joists with new plywood web and sawn lumber bottom chord members designed to act compositely with the existing floor joists as top chord members. (Figure 2) The strengthened timber joists were enclosed with fire-rated sheathing to meet building code requirements.

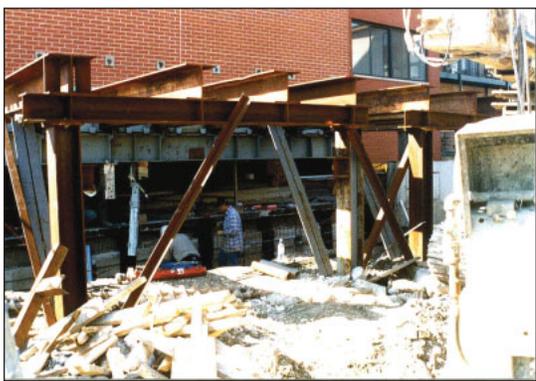
Figure 3 — Needle beams supporting five-story structure during foundation repairs.

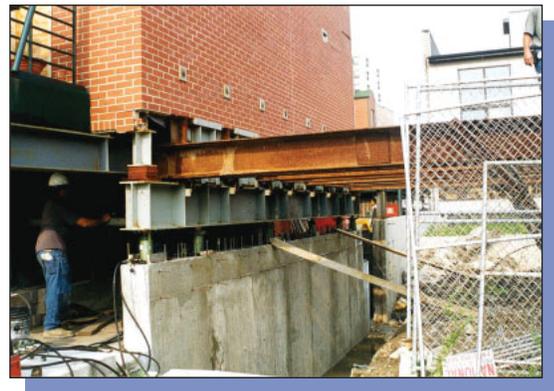
Figure 4 — Hydraulic jacking of structure from newly-placed concrete foundation.

As part of a repair program, an assessment is made to determine the need for restoring the building structure to its original elevation. On certain projects, RRJ has specified hydraulic jacking as a means for raising the building to its original position. (Figure 4) The suitability of jacking as an effective repair technique depends on the type of construction and the nature of damage. Structures that have formed hinged planes of deformation during settlement, such as with steel construction,
