A technical newsletter by Raths, Raths & Johnson, Inc. for the construction industry.

Project Profile
Benefits and Pitfalls
of Tile
Floor
Construction
Using Poured
Concrete
Underlayment

Benefits and Pitfalls of Tile Floor Construction Using Poured Concrete Underlayment

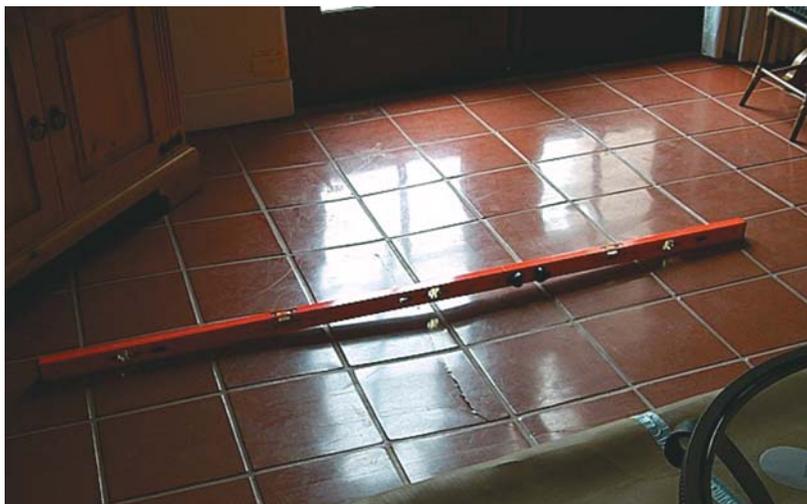
Figure 1—Typically cracked and deflected tile floor system observed throughout the above grade guest rooms at the complex (as discussed in the Project Profile article).

RRJ conducted visual surveys which indicated varying degrees of floor tile cracking present in virtually every above-grade guest room (Figure 1). Additionally, RRJ was shown instances of severe framing deterioration, reportedly caused by water infiltration. RRJ implemented an investigation involving crack mapping, detailed floor level surveys (Figure 2), invasive testing to document the condition of the wood framing and the extent of

- Floor tile cracking was entirely reflective of cracks in the concrete underlayment.
- Underlayment cracking was due to a combination of excessive deflection of the wood floor system and excessive shrinkage likely due to high water/cement ratios and improper curing.
- Widespread water intrusion was responsible for reduced stiffness and deterioration of the wood structure.
- The absence of control or expansion joints contributed to cracking of the tile and underlayment.

Based on the RRJ findings, the owners were able to effectively focus remediation efforts on the mitigation of waterproofing defects and on proper reconfiguration of the floor system details. RRJ developed graphics and animations which clarified the issues for the owners (Figure 3).

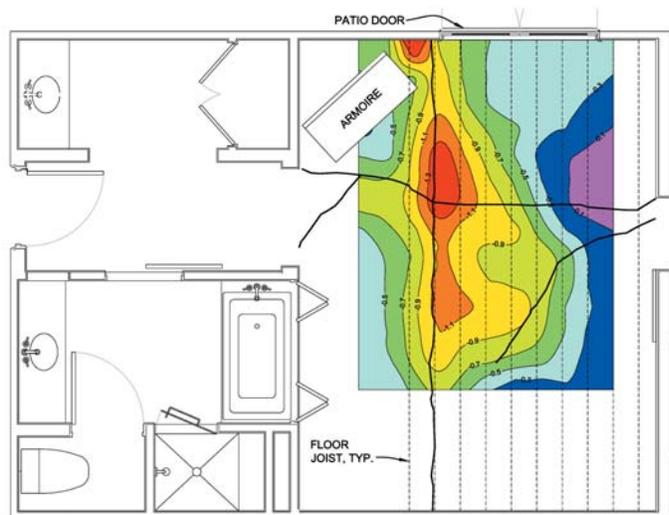
Figure 2—Crack map, floor level contour map and floor joist locations superimposed on guest room floor plan.

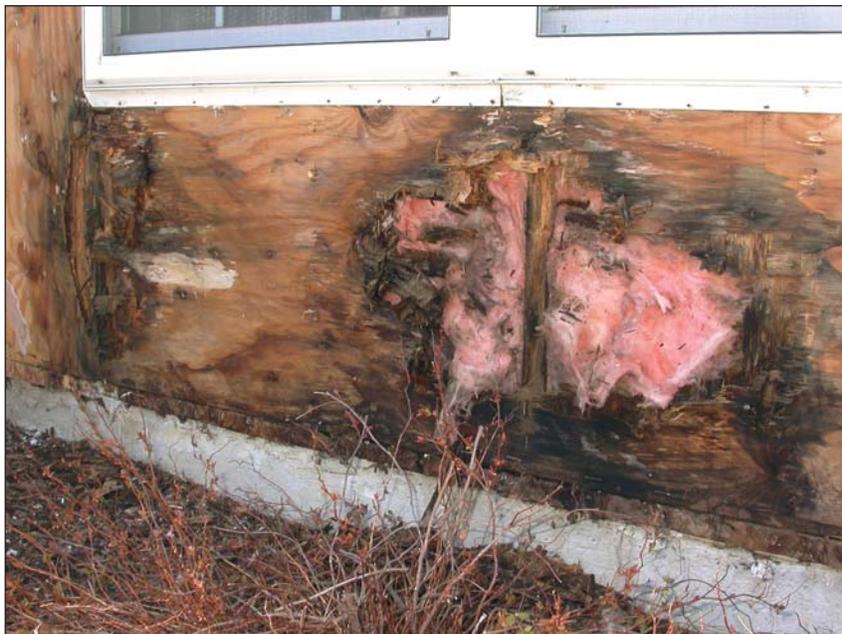
Figure 4— Decay of wood-based construction products due to water intrusion.

that are not identified by moisture content readings alone and may require the involvement of a Certified Industrial Hygienist or other qualified professional. Therefore, knowledgeable professionals should be employed to ensure proper use of investigative tools and resultant data. Diagnosis and repair of moisture-related problems should be performed upon identification to reduce potential damage and impact to building performance.
