INSIGHT™

ISSUE NO. 15

Two Mellon Bank
Center Terra
Cotta Restoration

Facade
Inspections—Going
Beyond the Surface

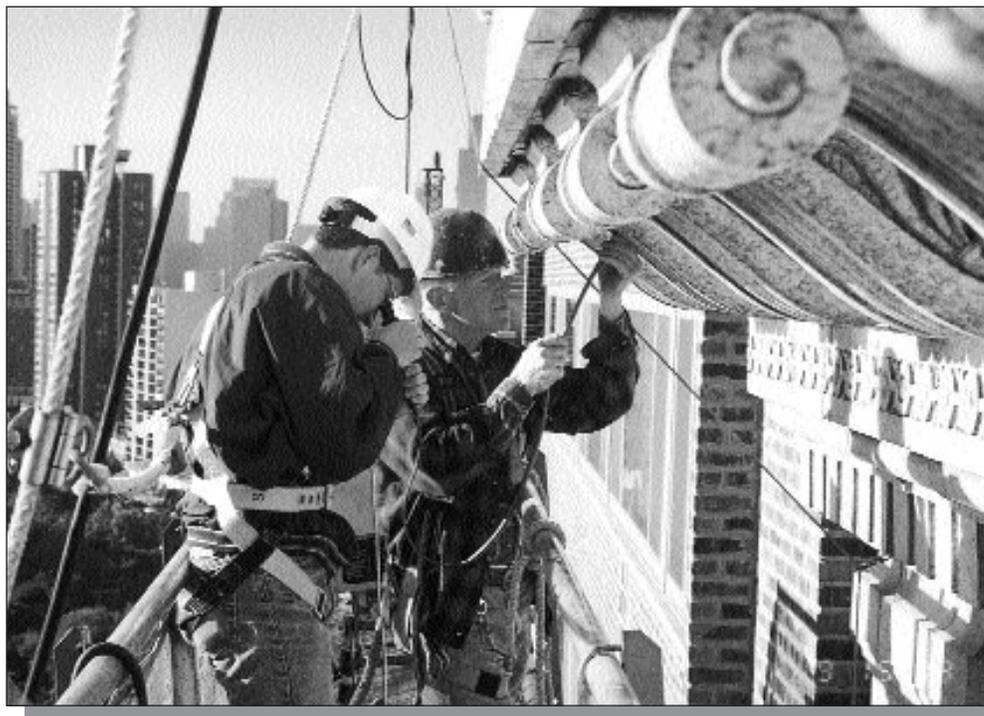
Inspection of hidden terra cotta anchors using a fiberoptic camera.

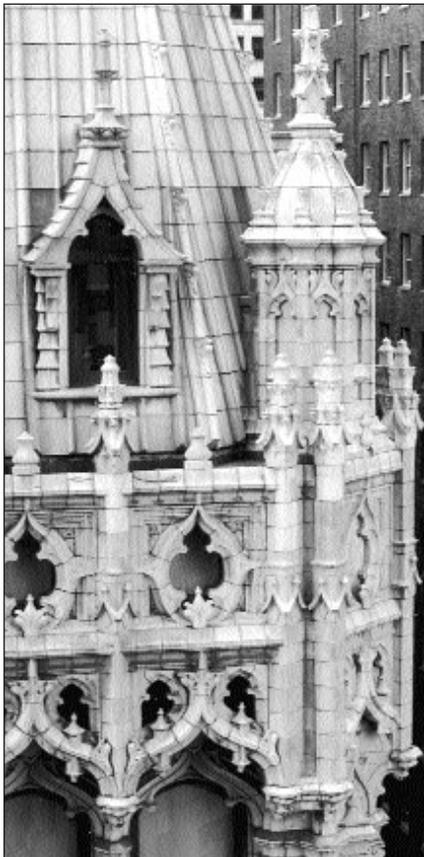
Figure 1 – Terra cotta clad penthouse, one of two on the building.

Prolonged water leakage in the penthouses and at the perimeter of the upper main floor areas caused concern over the condition of the terra cotta and supporting steel elements, and prompted the Owner to retain RRJ to evaluate the facade. Diligent “excavation” through over 70 years worth of accumulated drawings in the basement plan vault located portions of the original structural and architectural plan sets (ink drawings on linen), as well as some of the terra cotta shop drawings, and restoration plans from 1984. Armed with this information RRJ proceeded to document existing terra cotta conditions through a combination of binocular and close-up examination requiring the installation of a custom-fabricated man basket system capable of three axis movement (up/down,

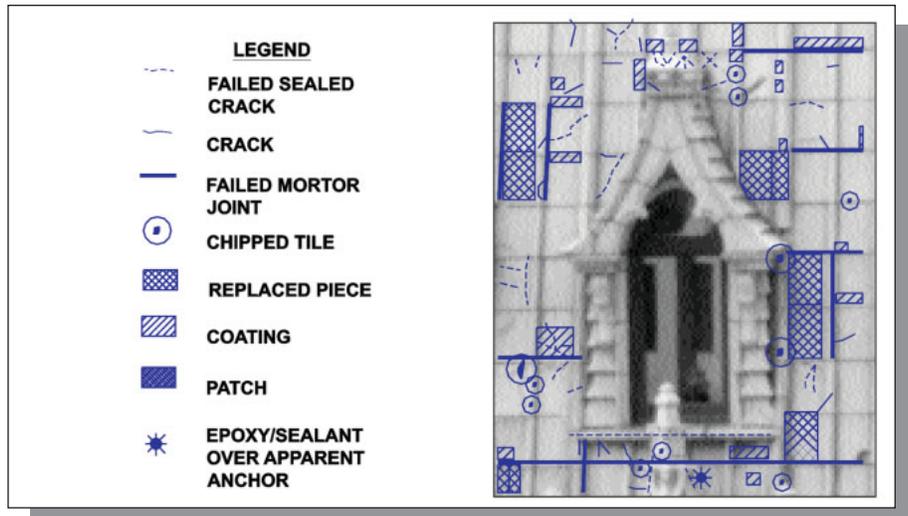
Figure 2 – Small portion of inspection recording sheet which uses a scanned photo of the actual building for plotting observed defects.

RRJ’s inspection data was compiled into a set of detailed condition drawings showing the exact location (on a piece-by-piece basis) of all significant cracks, chips, glazing spalls, broken pieces, deteriorated mortar joints, and previous repairs (failed and intact) observed. (See Figure 2.) This information was then used to prepare terra cotta restoration plans and specifications addressing the deficiencies noted above as well as the need for supplemental hidden water diverters to control leakage at the mansard dormers. Repair implementation is following a phased approach with full-time inspection. One elevation is being addressed each year with completion anticipated in 2002, followed by periodic re-inspection to monitor the performance of the repairs.

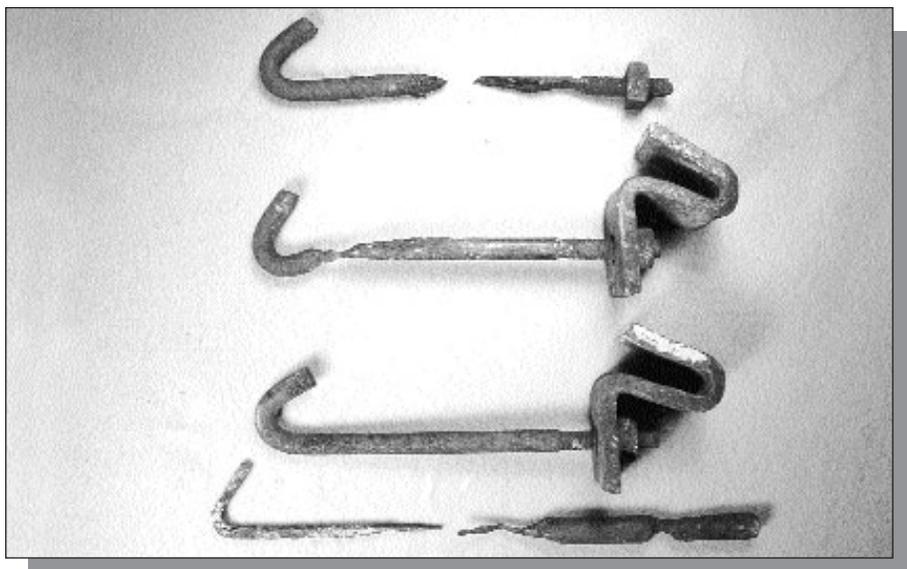
materials which rely on header coursing and/or hidden steel anchors and ties. Unfortunately, the deterioration of these critical structural components is concealed and problems are often impossible to detect from the exterior, even with close-up examinations. **Our firm has made investigative openings in areas of facades with no visual evidence of a problem on the exterior surface only to discover completely corroded anchors and ties lay beneath the exterior skin (see Figure 3).** An investigation which includes subsurface observations with a fiberscope or destructive openings through the exterior skin materials is often necessary to verify the condition of critical elements which are concealed within the exterior walls.

Figure 3 – Hidden anchors removed from a terra cotta facade showing varying degrees of corrosion.
