A technical newsletter by Raths, Raths & Johnson, Inc. for the construction industry.

Vintage Timber Truss Roofs: Collapses Waiting to Happen

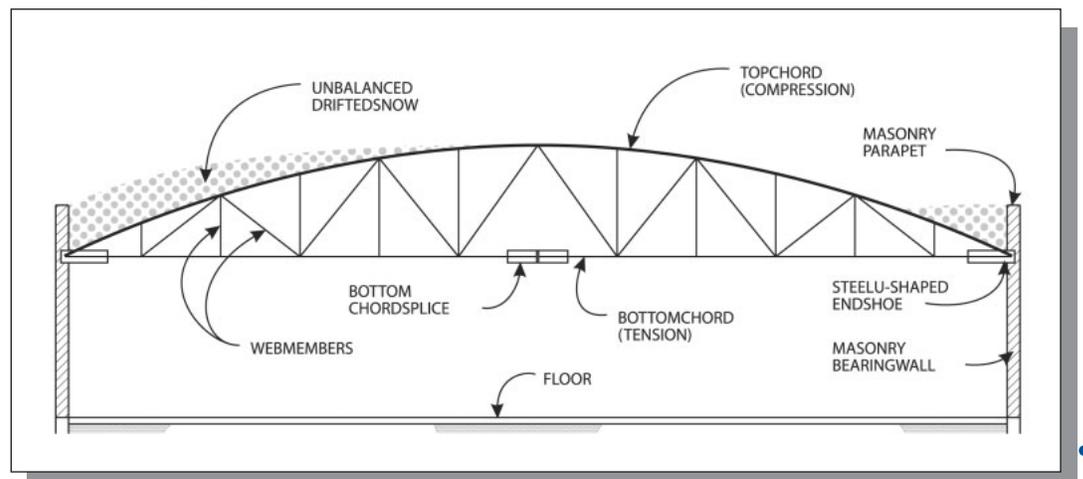
Figure 1 – Schematic of timber roof truss with drifted snow loads shown.

Another common truss design issue involves snow loads. Early building codes assumed roof snow accumulations were of uniform depth. In reality, wind frequently forms snow into drifts that can be significantly deeper than the average snow depth. Snow drifts behind raised building parapets, adjacent to higher portions of the same building, and on the leeward side of curved or sloping roofs can produce off-center or unbalanced roof loads far in excess of those predicted by the early codes.

This phenomenon was not specifically recognized in most building codes prior to the mid-1970s. The additional load, and its off-center location, can pose significant problems for older trusses by changing the distribution of forces in truss member components, resulting in their overload. Bowstring trusses, which behave principally as a tied arch under uniform loads, are particularly vulnerable to unbalanced loadings.

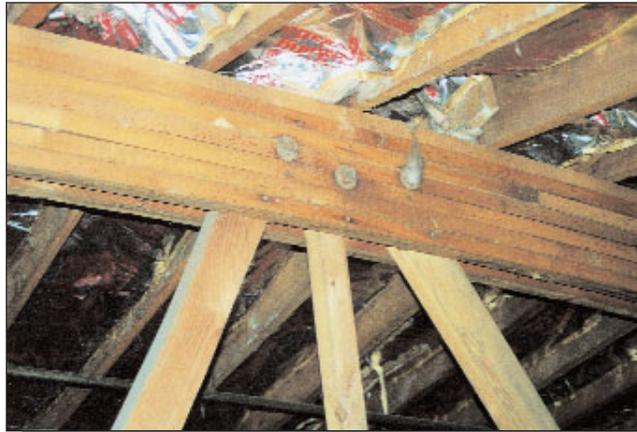
A variety of timber roof truss configurations have been used over the years. One of the most common types is the bowstring truss, so called because of its arched top chord profile (see Figure 1). Roofs constructed with bowstring trusses became popular in the late 1930s, and are readily identified by their curved shape. Although several systems were used in their manufacture, the most popular method was to construct both the top and bottom chords with two parallel members. In this arrangement, the web members were sandwiched between the chords and connected with bolts (see Figure 2).

*Figure 2 – The web members on this bowstring truss are bolted to the dual laminated top chord members.*

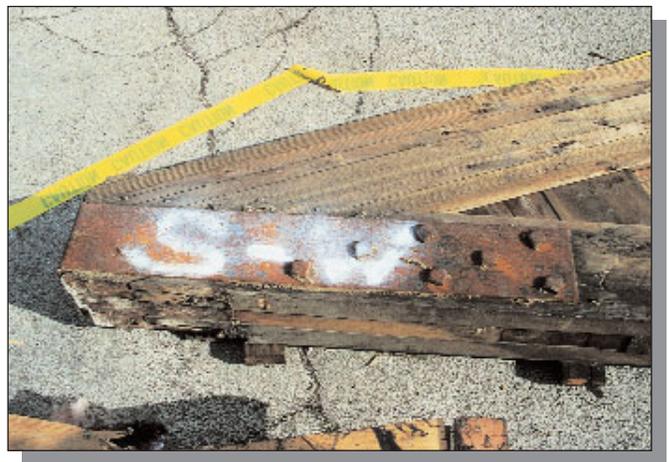
curved shapes or laminating multiple smaller pieces bent over a jig to the desired shape. Bottom chord members were typically constructed with large, straight lumber members joined with either wood or metal bolted splice plates, located near mid-span, to achieve the required length. The top and bottom chord members were fastened together at the truss ends with U-shaped steel heels, or end shoes, bolted to both chord members (see Figure 3).

*Figure 3 – This bowstring truss end, complete with the bolted steel end shoe, was removed from the southwest corner of a collapsed building investigated by the authors.*

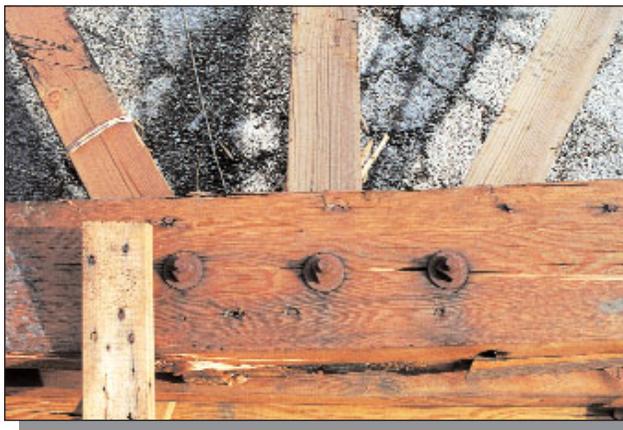
Unfortunately, the analytical methods typically employed prior to the wide-spread availability of computerized structural analysis programs in the 1980s did not fully consider the effects of member continuity, connection eccentricity (the offset between theoretical member center lines and the actual connection points) and the semi-rigid nature of multiple-fastener connections. These conditions can combine to produce actual truss member stresses significantly higher than those anticipated by the original designer, and frequently result in connection splitting failures that ultimately endanger the entire truss (see Figure 4).

*Figure 4 – The bottom chord members on this timber roof truss failed by splitting through the bolted web connections.*

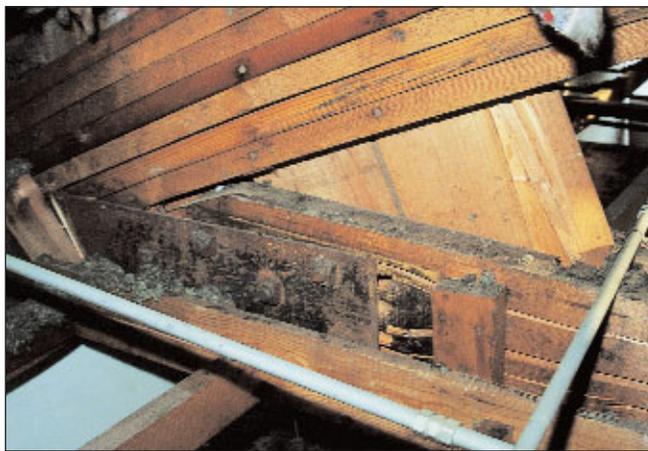
The end connections on bowstring trusses are critical to the overall truss performance. The bolted, steel, U-shaped end shoes at these locations transfer large thrust loads from the top chord members into the bottom chord. Rot and decay cause the wood to soften and lose strength, resulting in top-chord shortening from crushing

against the steel shoe, localized sagging of the bottom chord, and elongation or splitting of the end shoe bolt holes (see Figure 5). Long-term deterioration of truss ends often results in failure of these connections and consequent loss of truss action. When the end connections

deteriorate or fail, the outward thrust from the top chord is no longer resisted by the bottom chord. Instead, thrust loads push outward against the supporting masonry walls, resulting in bowing of the walls and, if left unchecked, complete collapse of the roof.

*Figure 5 – The end shoe connection on this bowstring truss has failed by splitting the bottom chord members. The truss end has spread over two inches, pushing the masonry wall outward.*

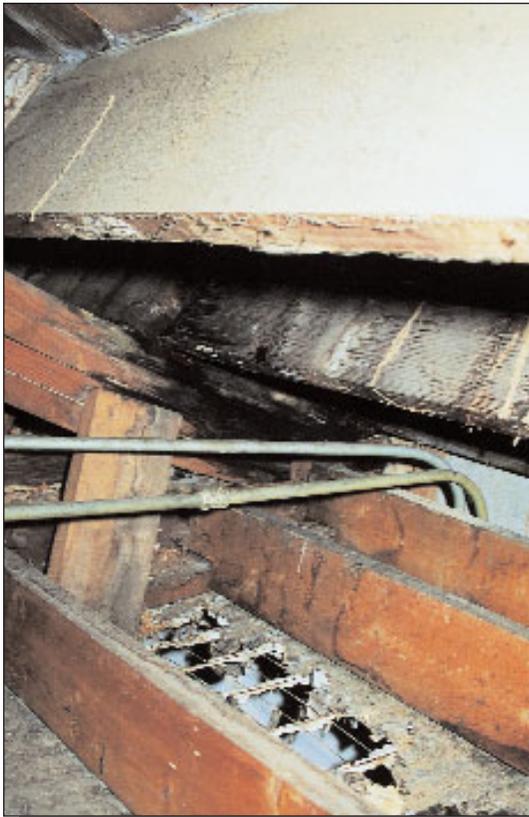
*Figure 6 – The bowstring truss end has been severely rotted from long-term roof leakage. Water stains, black rot, top chord reverse curvature and ceiling water damage are all present in this view.*
