INSIGHT

ISSUE NO. 6

Project Profile
The Warrington
Condominium
Restoration

The Warrington Condominium Restoration

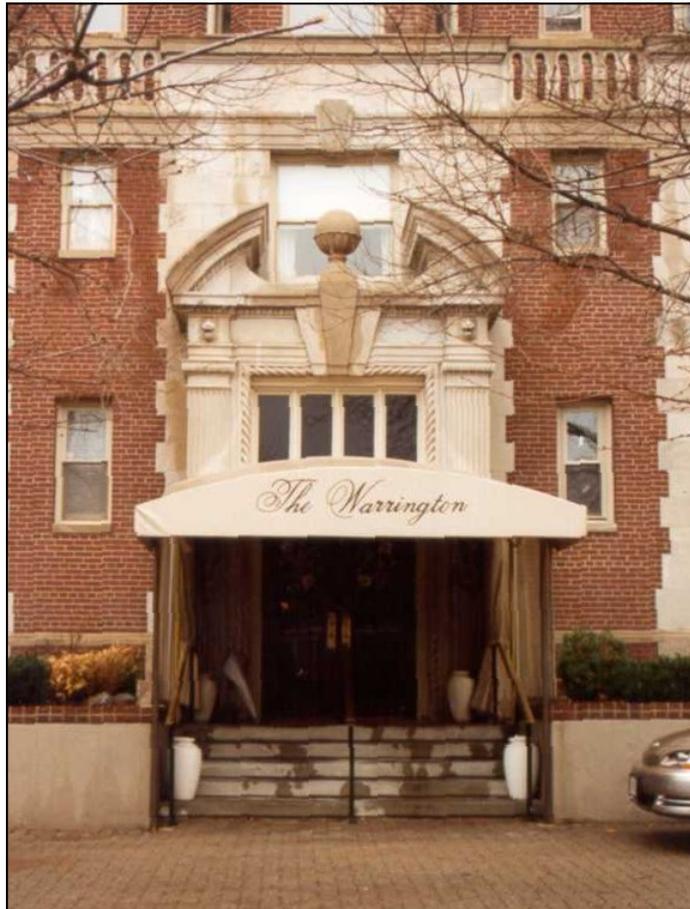
Warrington Condominium built in the early 1920's, a classic structure with typical masonry expansion problems.

For the last 70 years, The Warrington has performed like the solid, high class building befitting its prestigious address. Over the years, the brick facade has developed numerous cracks and the structural steel supports deeply embedded in the limestone balustrades and dormers, have corroded and expanded. This expansion has created irreversible movements which cracked the bricks and forced the stones apart

sonry design recommendations, is not always considered today and continues to regularly be responsible for similar problems in modern buildings routinely investigated by RRJ. The repair is the same, relieve the expansion by cutting in new joints where nature has cracked the walls.

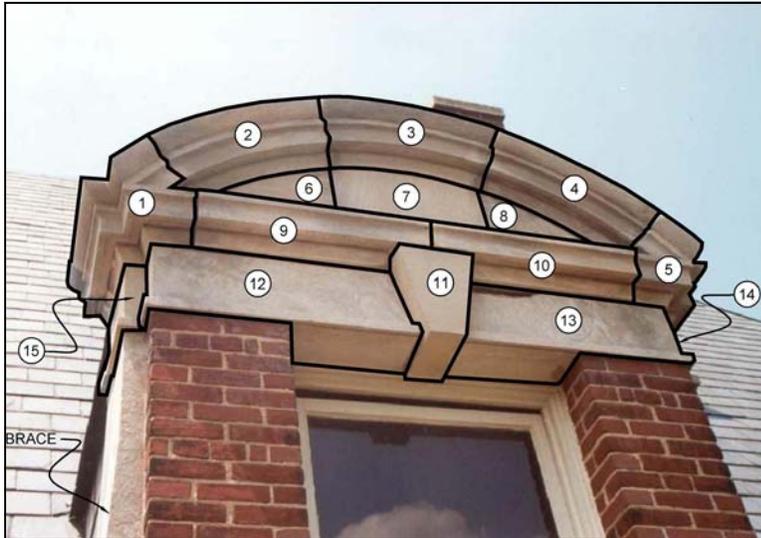
Method used for tracking stone pieces during removal and reinstallation.

Additionally, we found expansion of rust pack at steel angles used to support the limestone pieces of the dormer and balustrades had forced the stones apart and in the process **weakened the steel angles to a point where they now require replacement.** The figure shown was used in the repair documents to number and identify the stone of the dormer which needed to be removed and replaced to access the steel angle.

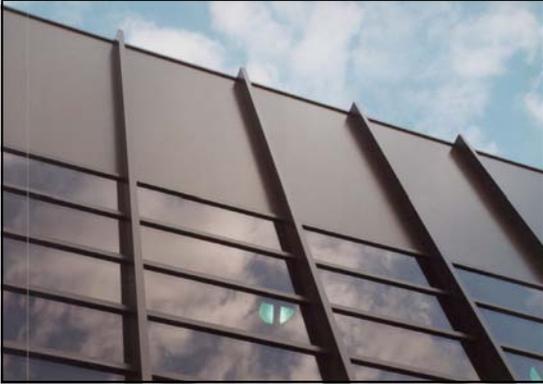
Figure 1—Multiplanar test area found on curtain wall and window system with protruding mullions.

The resulting multiplanar exterior envelope surfaces typically have frame seals and stack joints positioned significantly outboard of the glazing seals (Figure 1). The question then arises, **how should the Monarch nozzle be positioned to apply approximately equal pressure to all joints of interest.** To address

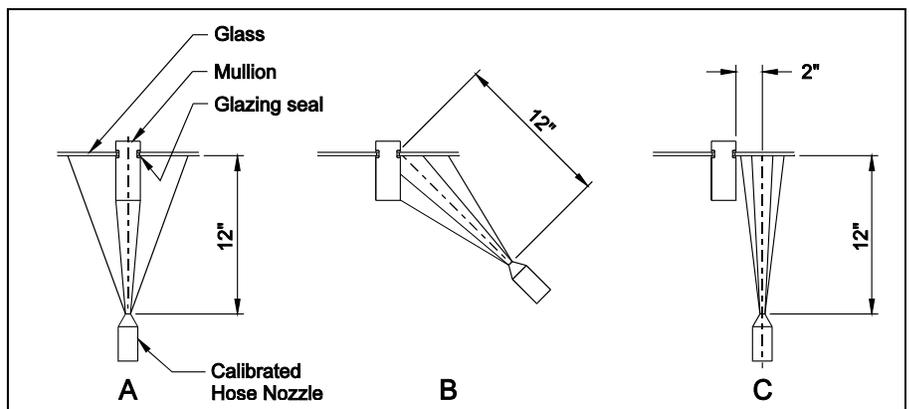
The first configuration tested had the nozzle aligned with the mullion centerline (Figure 2A). Pressure probes installed in the mock-up indicated this configuration yielded no measurable water impact pressure at the glazing. The water simply missed the glazing seals because of the shielding effect of the mullion.

RRJ next tried angling the water spray into the corner formed by the mullion and glass intersection (Figure 2B). Water hitting the glass and mullion was directed into the corner causing the measured impact pressures to in-

crease to approximately 20 psf. Since the angled approach produced pressures significantly higher than 7 psf generated by spraying a flat test area, RRJ tried a third configuration. In this test series, the nozzle was directed perpendicularly at the glass adjacent to the mullion (Figure 2C). In this position the glazing seal is wetted by water deflected by the glass surface alone. With the nozzle placed at a lateral offset of 2 inches from the mullion edge, pressures at the glazing seal measured approximately 7 psf, success!

Figure 2—Nozzle configuration for hose testing.

This work demonstrates that uniform impact pressures can be achieved using the monarch nozzle, but only if care is taken in the placement and orientation of the spray nozzle. In multiplanar systems, indiscriminate spraying can easily result in either negligible or excessive impact pressure being applied to the test joint.
