# INSIGHT™

ISSUE NO. 21

A technical newsletter by Raths, Raths & Johnson, Inc. for the construction industry.

## Indian Prairie Public Library

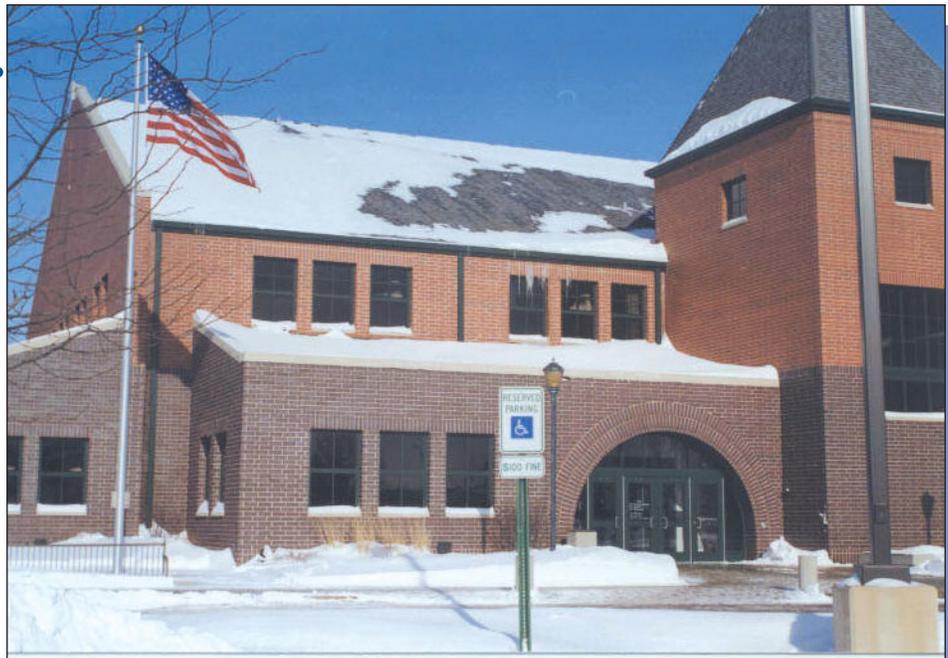
*Figure 1 — Indian Prairie Public Library with snow on the roof and ice damming present at the second level.*

The Indian Prairie Public Library (IPPL) is a two-story brick-clad building in suburban Chicago. The roof was designed as a cathedral ceiling utilizing prefabricated vented roof panels, a continuous roll roof vent, and asphalt shingles. RRJ was retained by the Library Board of Directors to investigate and design repairs to address interior water leakage experienced year-round since the building opened. The investigation identified deficiencies in the walls and roof that were contributing to the leakage experienced by the occupants. Additionally, improper design of the roof ventilation was identified and found to be contributing to the formation of ice dams.

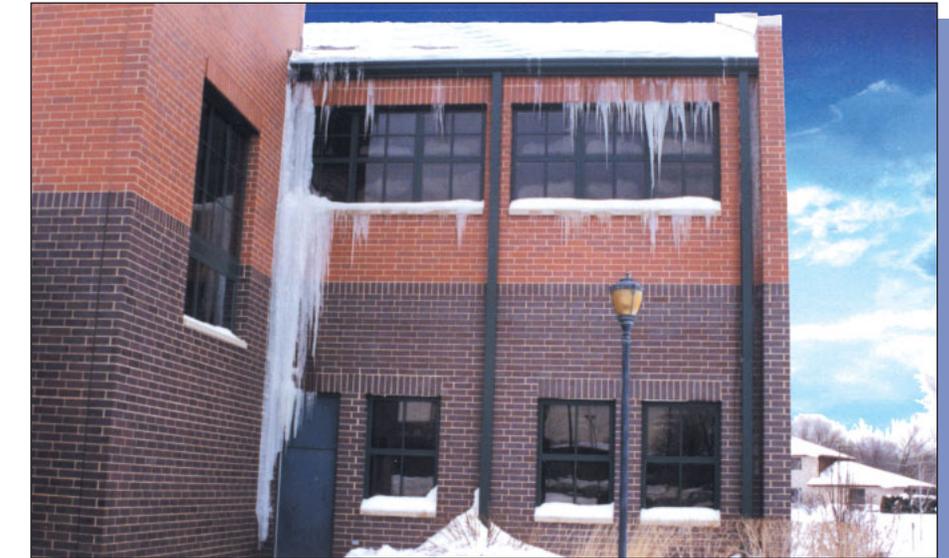
Figure 2 – Severe ice damming.

Cathedral ceilings and attic ventilation require proper balance of outdoor air intake and exhaust to perform as intended. In cathedral ceilings, some type of vent channel is needed to connect the top (ridge) and bottom vents (eave or soffit). When attics are used, the principles remain the same, but the attic space connects the top and bottom vents. At IPPL, the vented roof panel included a ridge vent, but did not include eave or soffit venting to the exterior. Instead, the vented roof panel was left open to the building interior at the eave. This resulted in supplying interior conditioned air into the vent panel instead of outdoor air. During the winter, this air path warmed the deck sheathing and asphalt shingles, and under certain weather conditions created ice dams (see *Tech Tip* article for more information on ice dams). The ice damming was so severe that icicles from the second floor partially blocked an emergency exit on the ground floor of the building as shown in Figure 2.

Developing repair designs to address the ice dams required blocking air paths from the interior and providing thermal insulation at the eave to reduce heat loss. Installing new intake vents at the eaves presented a challenge because the building design did not include a roof overhang that would allow for installation of soffit vents. The eave

configuration also included gutters that further complicated the repairs. The solution was to modify the air path by extending the vented roof panels to the eaves and adding eave venting behind the gutters. The gutters were reinstalled over new supports and a manufactured vent product, which allowed for proper air intake without changing the aesthetics of the building.

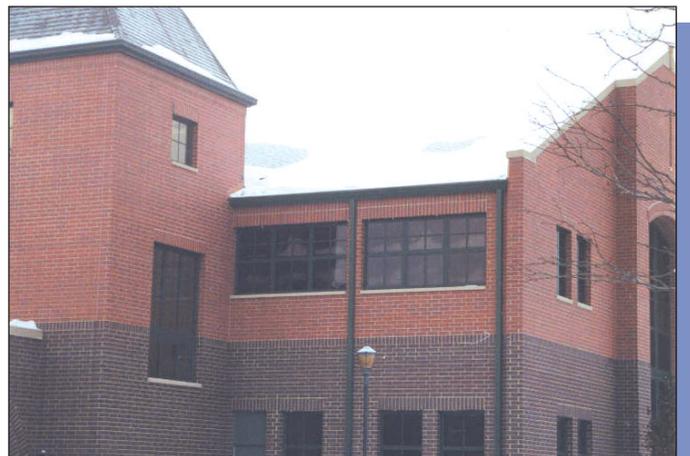
Figure 3 – Same view as Figure 2 (above) after repairs were implemented. Ice dams do not form.

In addition to correcting the vent design, an air barrier and perimeter insulation were installed to further limit air flow and heat loss through the building materials. These components are important on any project, as both can be significant factors in the prevention of ice dams. The roof-to-wall interface in typical construction can make it difficult to detail these areas properly. Design and installation of an air barrier and thermal insulation are critical at these locations.

Roof and attic ventilation are often misunderstood. This is one of the reasons that ice dams and the resulting damage are so prevalent in cold climates. At IPPL, RRJ's repair designs effectively prevented interior air from directly warming the roof and reduced heat loss at the eave by properly insulating the building perimeter. Similar concepts can be applied to mitigating ice dams on most sloped residential and commercial roofs.

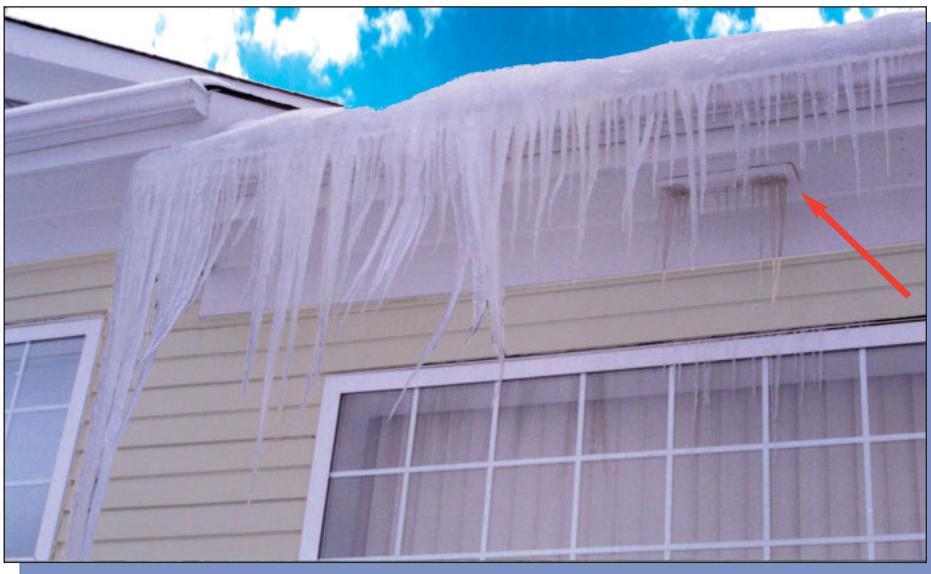
Figure 4 — An example of severe ice damming. Icicles hanging from the soffit vent (arrow) indicate melt water has penetrated the roofing and roof sheathing.

Ice damming, quite simply, is the troublesome build-up of ice along roof eaves that causes a back-up of meltwater behind it. The ice build-up can pry up roof shingles and distort gutters and roof flashing. The backed-up meltwater can ultimately work its way through to the interior of the building, damaging roof sheathing, attic insulation, interior finishes, and anything else in its path. If the meltwater back-up is high enough, it can overtop the ice dam and form large icicles along the eaves. Both the icicles and the large blocks of ice can become falling hazards once the weather warms up.
