# INSIGHT™

ISSUE NO. 9

RRJ’s Evaluation Demonstrates Code-Compliance of Beams With Radically Displaced Tendons

## Miami International Airport – Parking Garage 7

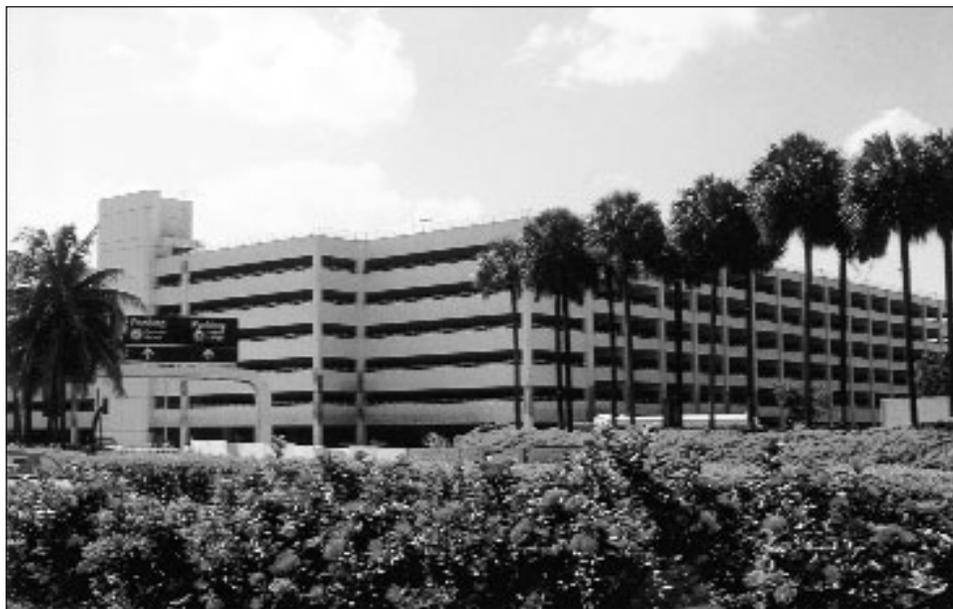
*Miami International Airport Parking Garage 7. Routine quality control procedures found significant potential problems. The General Contractor choose to identify and solve the problems thereby avoiding a litigious battle.*

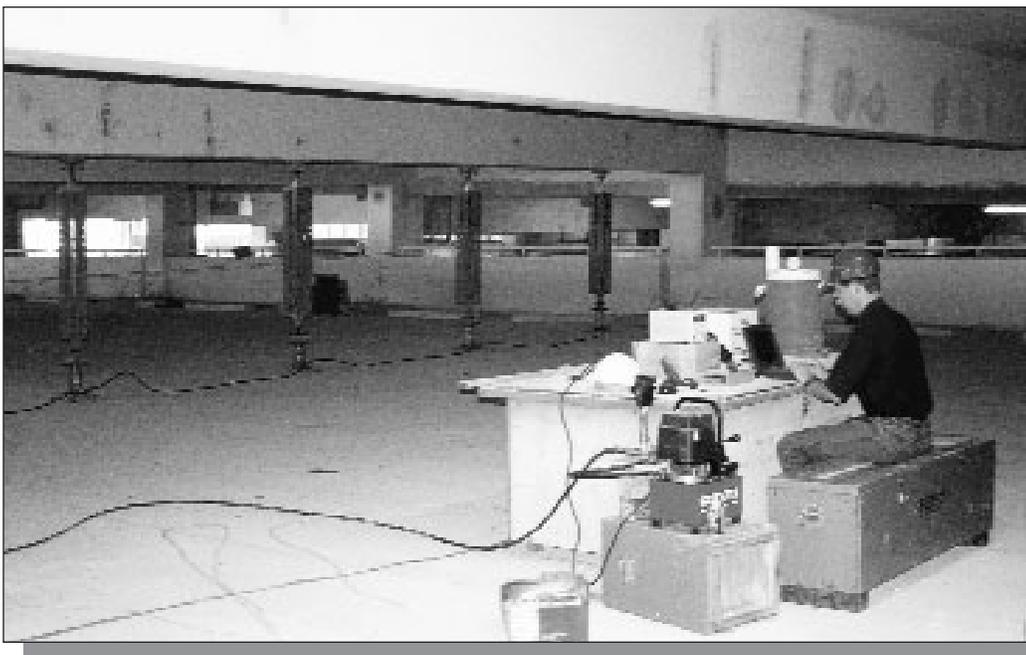
As shown in Figure 3, the test load was applied using a series of hydraulic jacks coupled together using manifolds to produce an equivalent uniform load along the beam length. Jacks were controlled by a hydraulic pump with metering valves and calibrated gages. Jack reaction forces were

Figure 3 - Load test consisting of hydraulic jacks coupled together with manifolds to apply an equivalent uniform load across the beam.

resisted by the self-weight of two constructed floors above the test beam. Catch shoring was installed below the tested member to prevent damage to the remaining structure in case the test member failed. Beam deflections and changes in crack width were monitored at selected locations using Linear Variable Differential Transducers (LVDT's). See Figure 2. Loads were applied in seven increments. At each load increment, beam
