BRICK BY BRICK: TRADITIONAL AND UNCONVENTIONAL MASONRY RESTORATION STRATEGIES

2023 IIBEC INTERNATIONAL CONVENTION & TRADE SHOW

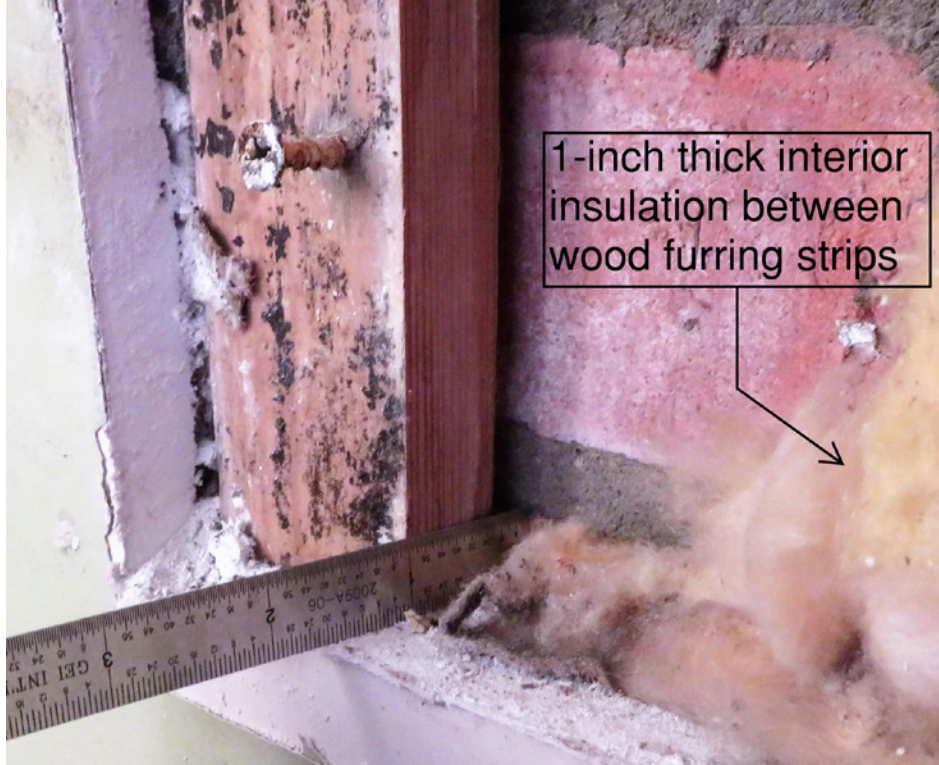
FIGURE 5. A thin layer of insulation provided on the interior side of a mass masonry wall.

The large thermal mass of mass masonry structures assists in reducing temperature fluctuations within buildings. As such, insulation was typically not provided within or inboard of the walls. In some cases, a thin layer of insulation was provided on the interior side of mass masonry walls (**Fig. 5**).

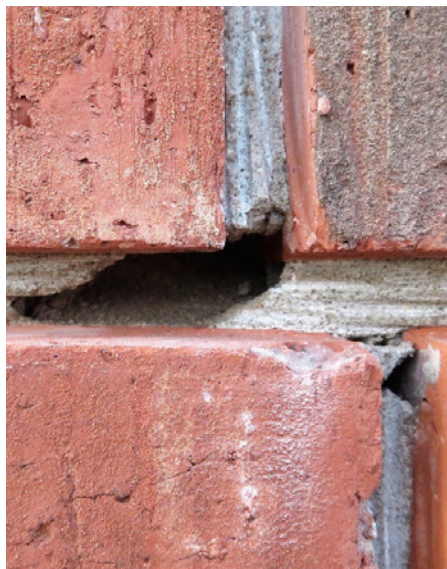
FIGURE 6. Voids in a mortar joint were uncovered following grinding during a repointing project.

However, without proper design and industry-standard construction methods, conventional masonry restoration strategies can have limited benefits or result in aesthetic concerns. As an example, repointing is a common repair practice that requires removing deteriorated mortar to a uniform depth and placing new mortar within the joint. The deteriorated mortar should be removed to a uniform depth that is a minimum of twice the joint width, generally $\frac{3}{4}$ in. (19 mm), or until sound mortar is reached. If mortar is not removed to an adequate depth, deficiencies in the joint within the depth of the wall may not be uncovered (**Fig. 6**). Repointing performed to a limited depth is likely to provide only minimal benefits when compared with grinding and repointing to at least a $\frac{3}{4}$ inch depth (**Fig. 7**).

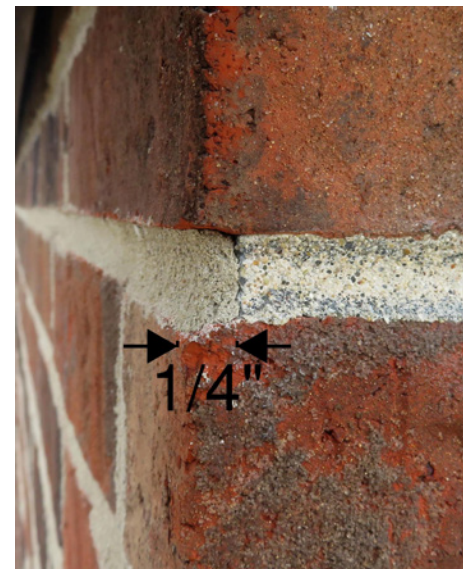
FIGURE 7. Mortar joint repointing to an insufficient depth of approximately $\frac{1}{4}$ in. (6.4 mm).

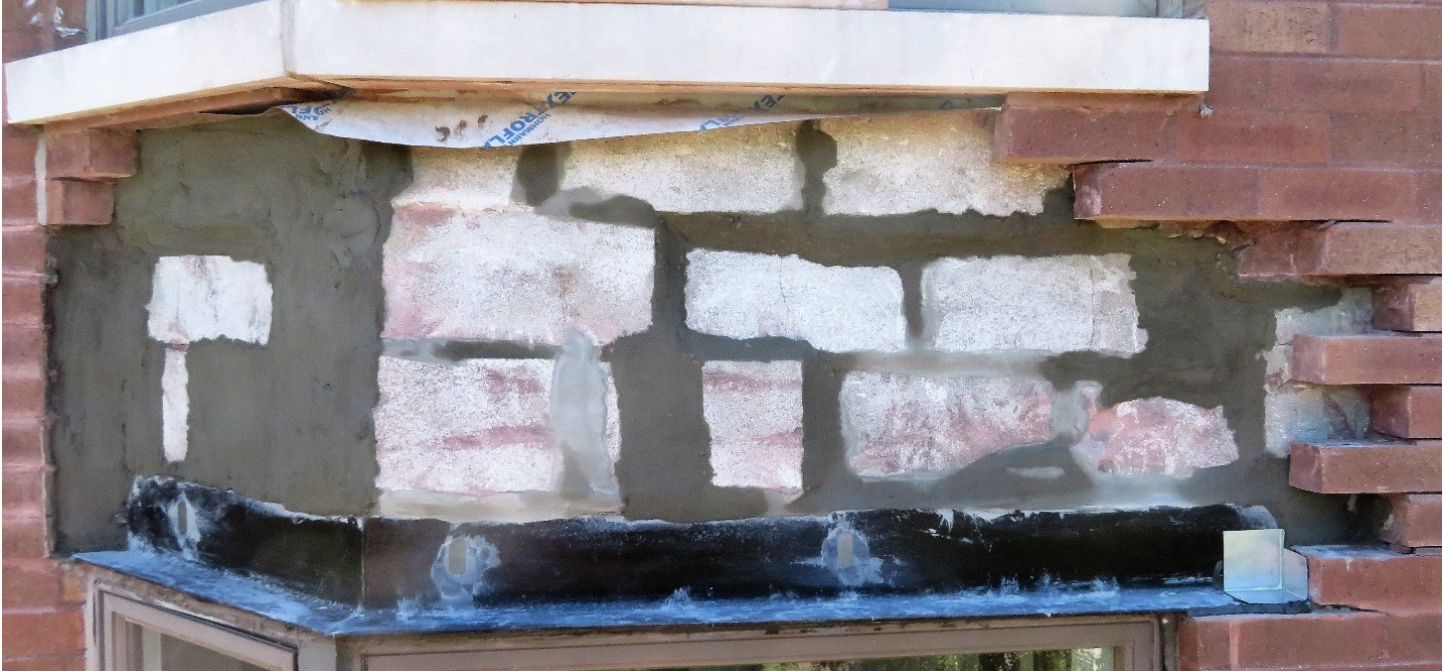
FIGURE 9. Preparation of a backup wall prior to installation of the AWB and through-wall flashing.

The condition of the backup masonry varied throughout the building and included areas of out-of-plumb masonry, loose masonry units, and significant voids in the backup CMUs. Project specifications required repairs to the backup wall in the form of repointing, parging, and unit replacement to ensure a suitable substrate for the AWB and through-wall flashing (**Fig. 9**). Although

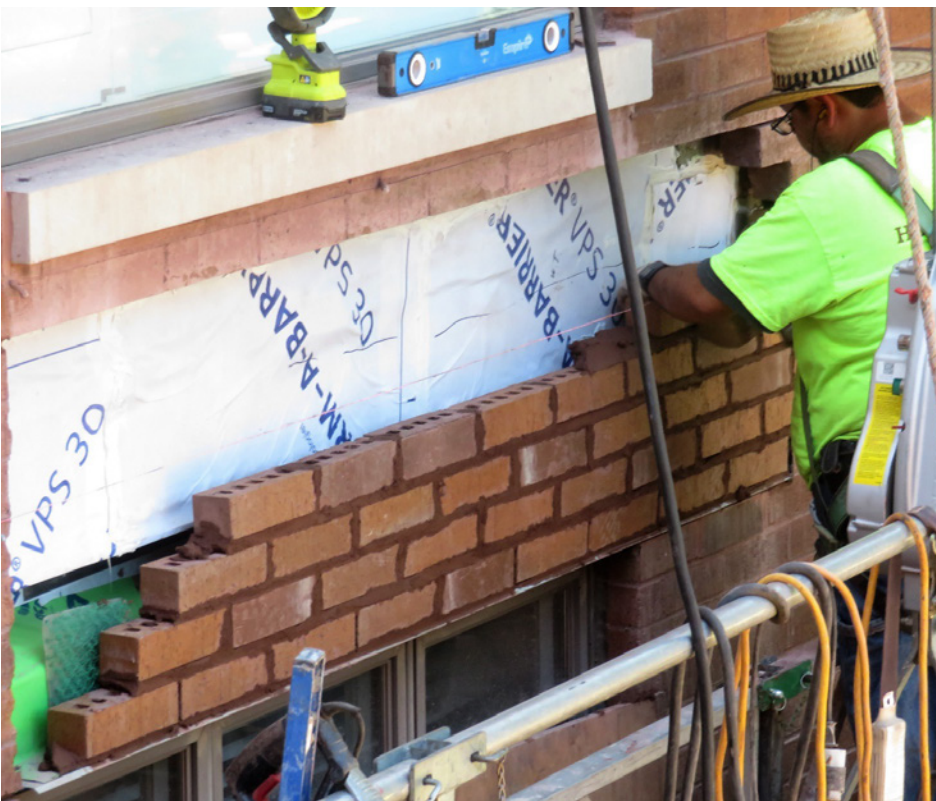
FIGURE 10. Installation of brick veneer following installation of the AWB and through-wall flashing.

traditional through-wall flashing repairs are typically limited to the three or four courses above steel lintels, the additional repairs performed for this project were intended to limit the possibility of water leakage through deficient areas of the backup wall

structure above the areas of through-wall flashing repairs (**Fig. 10**).

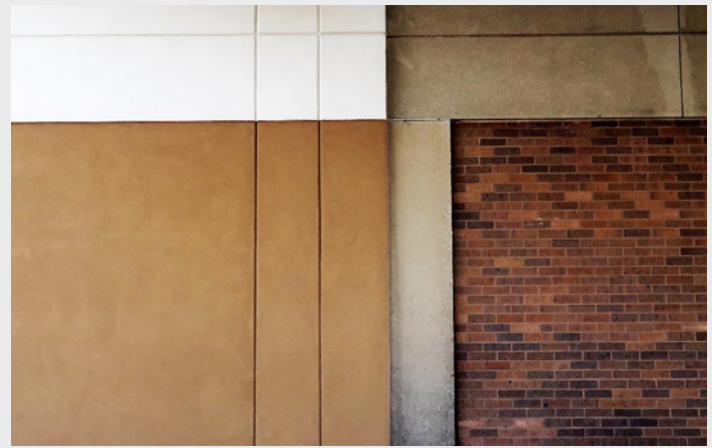
FIGURE 12. Completed overclad area of the EIFS adjacent to the existing masonry exterior wall.

To achieve a rainscreen design with continuous exterior insulation, the exterior of the existing masonry walls was restored by means of localized brick replacement and limited repointing to allow for application of a continuous AWB on the exterior face of the masonry. Mock-ups were used to verify adhesion of the AWB to existing substrates and the EIFS insulation to the AWB (**Fig. 11**) before work on the overclad commenced (**Fig. 12**). Thermal modeling was also performed to verify adequate thermal performance at window locations and at roof-to-wall transitions.
