A technical newsletter by Raths, Raths & Johnson, Inc. for the construction industry.

Project Profile
Benefits and Pitfalls
of Tile
Floor
Construction
Using Poured
Concrete
Underlayment

Benefits and Pitfalls of Tile Floor Construction Using Poured Concrete Underlayment

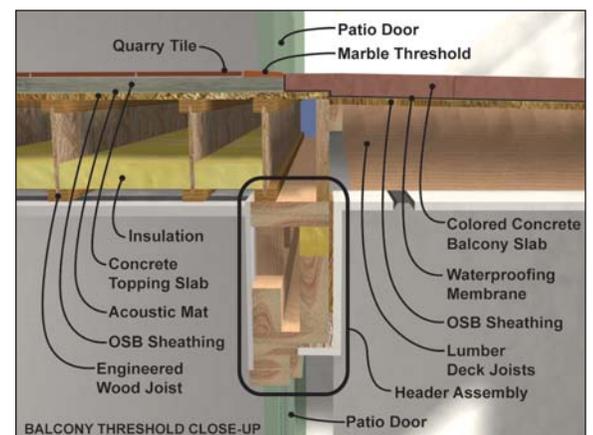
Based on the RRJ findings, the owners were able to effectively focus remediation efforts on the mitigation of waterproofing defects and on proper reconfiguration of the floor system details. RRJ developed graphics and animations which clarified the issues for the owners (Figure 3).

Figure 3—Color graphics were useful tools to help describe construction components for the owner.
