INSIGHT

A technical newsletter by Rath, Rath & Johnson, Inc. for the construction industry.

Lake Front High-Rise Rehabilitation

Pressures Generated During Curtain Wall Hose Tests

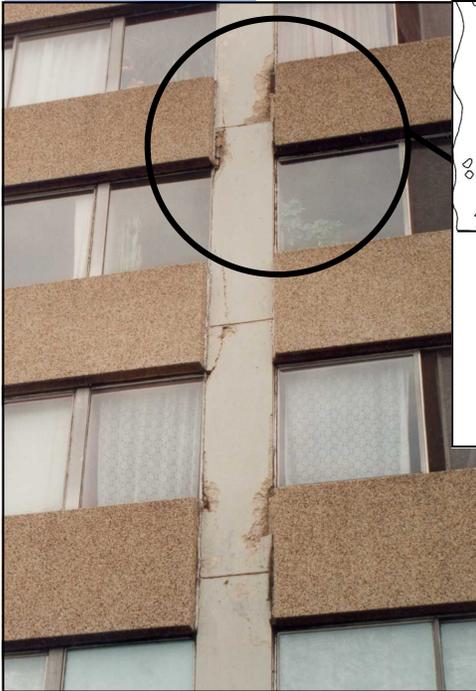
Spalling adjacent to spandrel panels caused by corrosion of concealed steel "water bar."

RRJ found that the continual intrusion of water had severely degraded the concealed steel components and precast spandrel panel connections. One of the most detrimental effects of water infiltration was the corrosion of a concealed "water bar" which exists in a key way pocket between the columns and precast panels. The expansive forces resulting from corrosion caused large spalls to occur on the face of the exterior columns. The resulting spall provided a means for uncontrolled water entry.
