A technical newsletter by Raths, Raths & Johnson, Inc. for the construction industry.

Performance
Criteria for
Weather-Resistive
Barriers

Design of Durable
Wall Systems by
Eliminating Food
and Water

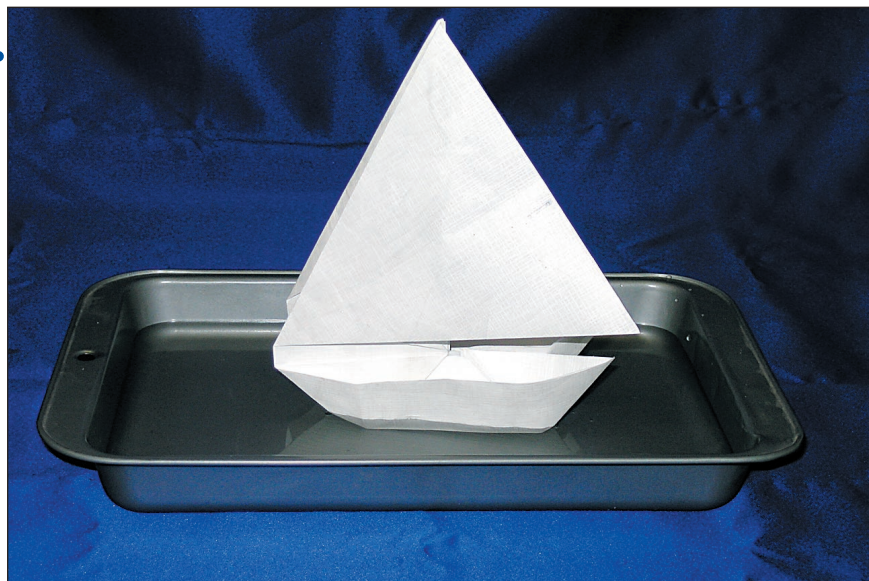
Figure 1 – Is this a rational test for evaluating water penetration?

One of the test methods prescribed by ICBO AC38 is ASTM D 779, *Standard Test Method for Water Resistance of Paper, Paperboard, and other Sheet Materials by the Dry Indicator Method*. This test standard involves bringing one side of the WRB in contact with water and measuring the elapsed time for liquid water penetration to occur. A common method of performing this test involves floating a small boat made from the product on water (see Figure 1). In order to meet the minimum standard for a Grade D barrier, the product must resist water penetration for ten minutes. The two other test standards cited by ICBO AC38 are AATCC 127, *Water Resistance: Hydrostatic Pressure Test* and CCMC 07021, *Water Ponding Test*. These test procedures subject the test specimen to a hydrostatic head of water for allotted time periods under different head pressures.

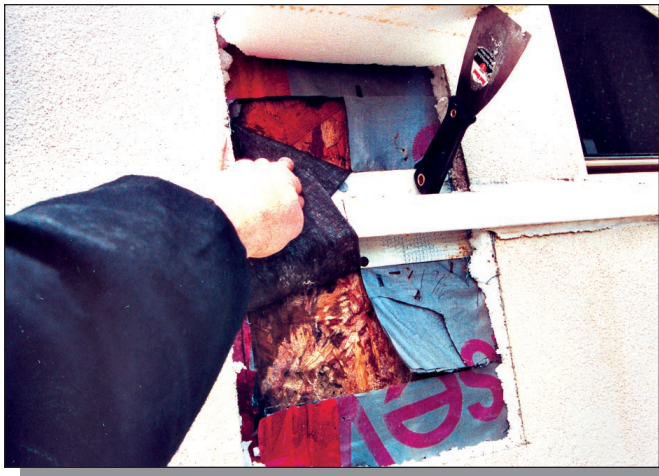
Figure 2 – Example of water damage due to water penetration through a polymeric WRB membrane.

During a recent field investigation of water intrusion problems with the exterior walls of a residential building, RRJ identified concerns with the water resistance capabilities of the polymeric weather-resistive barrier (WRB) installed over the wall sheathing behind the siding. On this project, water damage to the exterior wall wood sheathing and framing was

found in numerous locations. While some water damaged areas corresponded with conditions often associated with common paths of water entry, such as poor flashing installation and lack of integration of the WRB with other wall components, other locations of water damage did not. In fact, our investigation identified locations of water damage behind the WRB material where it was installed continuously and free from any penetrations that would allow water to intrude behind it. The water damage appeared to be associated with water penetrating through the protective WRB membrane. This finding prompted us to examine pertinent building code provisions, current test methods and to perform laboratory testing to study WRB performance. The results of these laboratory tests, which are currently underway, will be presented in *RRJ Insight* Issue 20.

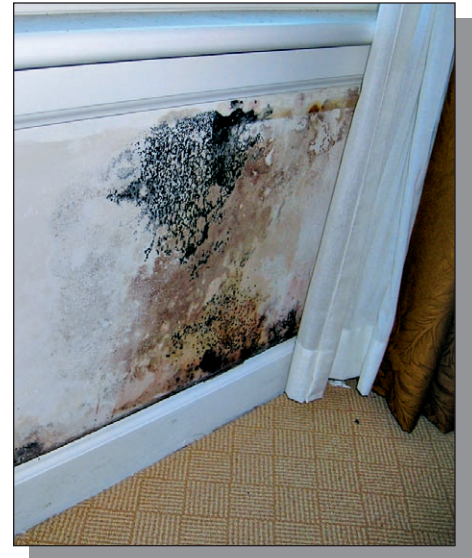
Figure 4 – Mold growth on gypsum wall

can retain water for long periods of time or is made with organic adhesives or additives. Our investigations of leaking buildings have commonly identified the presence of biological growth on the paper facing of gypsum sheathing or wood-based materials. Because paper and wood contain cellulose and are absorptive of moisture, these materials provide good conditions for mold to develop.

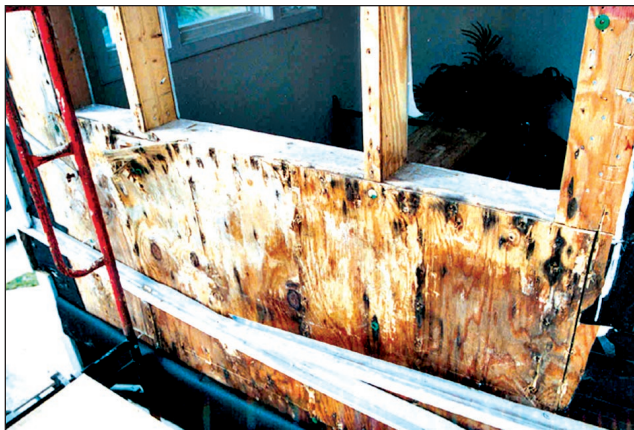
Figure 3 – Deterioration of sheathing and framing from water leakage at window openings.
